Preprint 01-113

"ADVANCE AND RELIEVE" MINING, A METHOD TO MITIGATE THE AFFECTS OF HIGH HORIZONTAL STRESS ON THE MINE ROOF

D. R. Dolinar, T. P. Mucho, and D. C. Oylar
Natl Inst for Occupatnl Sfty and Health
Pittsburgh, PA, USA

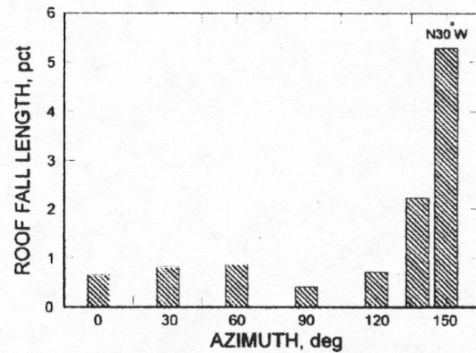
Figure 3. Direction of failed roof normalized by drivage in a given direction

Mapping of the stress damage also indicates the directional nature of the roof problem by documenting more subtle roof damage in addition to roof falls (Mucho and Mark, 1994). This stress damage is in the form of cutters or gutters (figure 4). In the panels, most of the stress damage again occurred in the N 30° W entries. In panel E13 about 23% of the drivage had stress damage in the form of cutters or guttering. Ninety-five percent of this damage was in the N 30° W entries with 45% of the drivage in this direction suffering stress damage.

Initially, to determine the direction of the maximum horizontal stress, the pattern of the roof falls was used. The highest percentage of roof falls occurred in the N 30° W direction (figure 3). This would indicate a maximum horizontal stress from N 60° E. However because there was no drivage between N 30° W and north, the actual maximum stress direction could be more toward the east. Therefore, the maximum stress direction could fall between N 60° E to N 80° E. It was assumed that the maximum stress could not be any closer to the east-west direction or to the N 50° E direction because of the limited amount of falls perpendicular to those directions. Therefore, a N 70° E direction was selected as the direction of the maximum horizontal stress for the design and evaluation of the "advance and relieve" mining method.

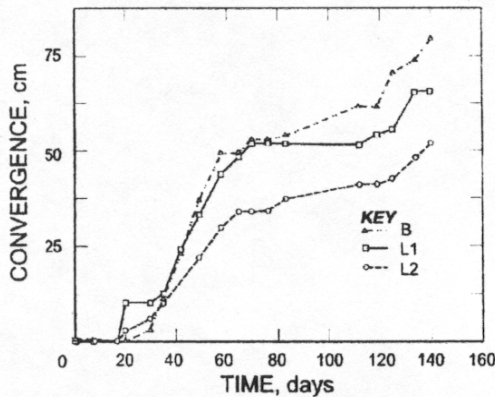
Figure 13. Floor heave rates across E17 panel

The maximum floor heave occurred in both panels during the first 245 m of "advance and relieve" pillaring. In E15 the average heave rate in this panel section was 0.6 cm/day, while in E17 the average rate was 0.96 cm/day. These rates were maintained for periods of up to 40 to 60 days before leveling off. In places, 50 to 75 cm of floor heave resulted. The floor heave occurred across the panel width and was not confined to the area adjacent to the cave. Figure 13 shows the pattern of floor heave over time across the E17 panel 60 m in by the start of pillaring. The accelerated rate of floor heave shown in figure 13 after 115 days is the result of retreat mining in the

panel. The variable initial rates between 20 and 30 days may reflect the failure of the hard shale layer.

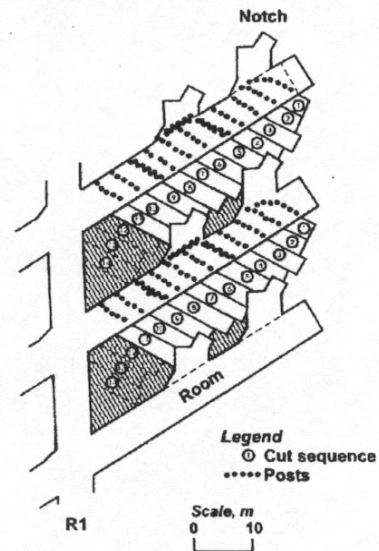
Figure 14. Pillaring plan in E19 that was changed because of floor heave

To address the floor heave issue, a third pillaring plan and a new panel design were developed and implemented in panel E19. The size of the pillars in the panel were increased by extending the distance between crosscuts to 21.3 m. Instead of a pillar remnant as was left in E15 and E17, a pillar was now left between the cave and the R1 entry that was on average 12.2 m wide. Figure 14 shows this third pillaring plan. A double notch was used to assure that a cut through was made during pillaring for both ventilation and caving. Besides the change in pillar dimensions, the width of the caved zone was decreased to about 24.4 to 27.4 m.

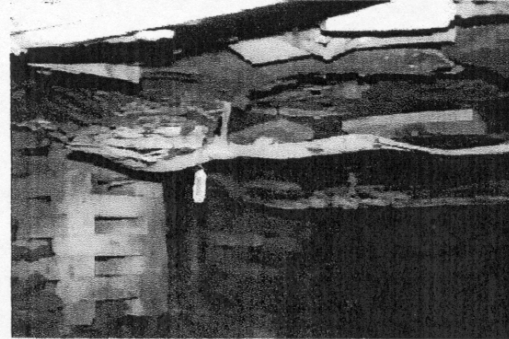
Figure 17. Rear abutment stress damage in L1 entry

Roof damage in the entries and crosscuts in the panels just outby the cave was probably caused by the rear horizontal stress abutment (figure 16). This abutment did not advance with the mining, but remained stationary. In E15, the damage consisted of cutters that developed in the R1 entry from the cave outby for a distance of approximately 60 m. This stress damage was parallel to the length of the cave. Stress damage also occurred in the crosscut just outby the cave. A cutter ran across the belt entry then into the crosscut from the belt entry to the L1 and L2 entries. This was a narrow zone about 3 m to 5 m wide of fairly severe roof damage that crossed the entire panel at a right angle (figure 17). Because the rear abutment was stationary, the damage from this abutment appeared to be more severe than that resulting from the forward abutment. The damage parallel to the cave in the R1 entry was probably caused by the concentration of the maximum horizontal stress. However, the stress damage across the panel may have in part been caused by the minimum horizontal stress.

To rehabilitate the damaged roof, cribs, posts and cable bolts were used as supplemental support in the R1 entry and across the panel along the narrow zone of damage. Similar, though not as severe damage was seen outby the cave in E17. Again supplemental support was used to control the stress damage. In E17 the damage approached but did not reach the mains.
