A case study of roof bolting tasks to identify cumulative trauma exposure

Kim M. Cornelius and Fred C. Turin
National Institute for Occupational Safety and Health
Pittsburgh Research Laboratory
Mining Injury Prevention Branch
Pittsburgh, PA 15236

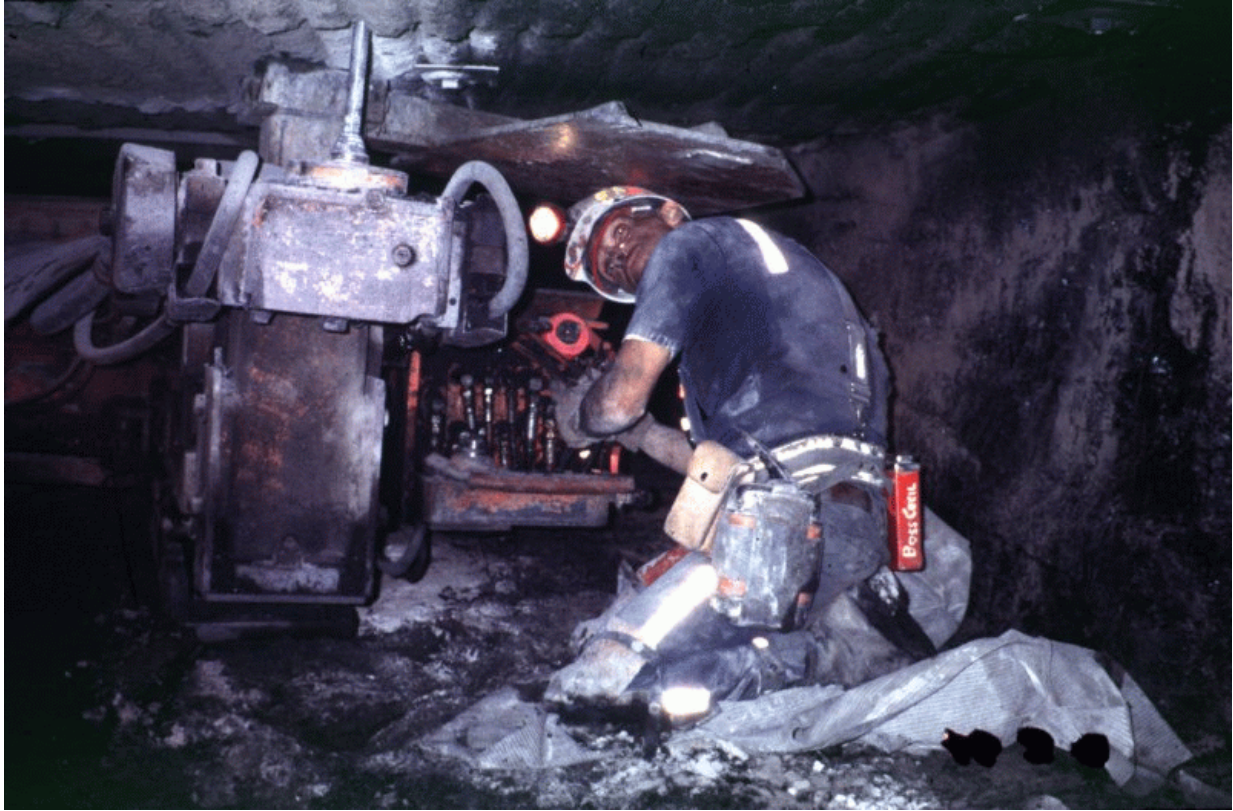
Figure 1. Roof bolting in a low seam mine often requires workers to maintain awkward postures.

In an underground coal mine, after an area is mined, it is necessary to support the roof to keep it from collapsing. Since 1950, the primary method for supporting the mine roof has been installation of roof bolts. Long bolts installed into the roof compress the layers of strata and suspend the weaker layers from a stronger layer above. Roof bolts, typically 6 - 8 feet long, are installed by workers using large roof bolting machines. There are different types of machines used for high, medium, and low coal seams. Typically in medium seam heights, 43 to 60 inches, and low seams, less than 43 inches, the operator works in a small area between the machine and walls of coal called ribs. A roof bolting machine operator working in a low seam mine is illustrated in figure 1.

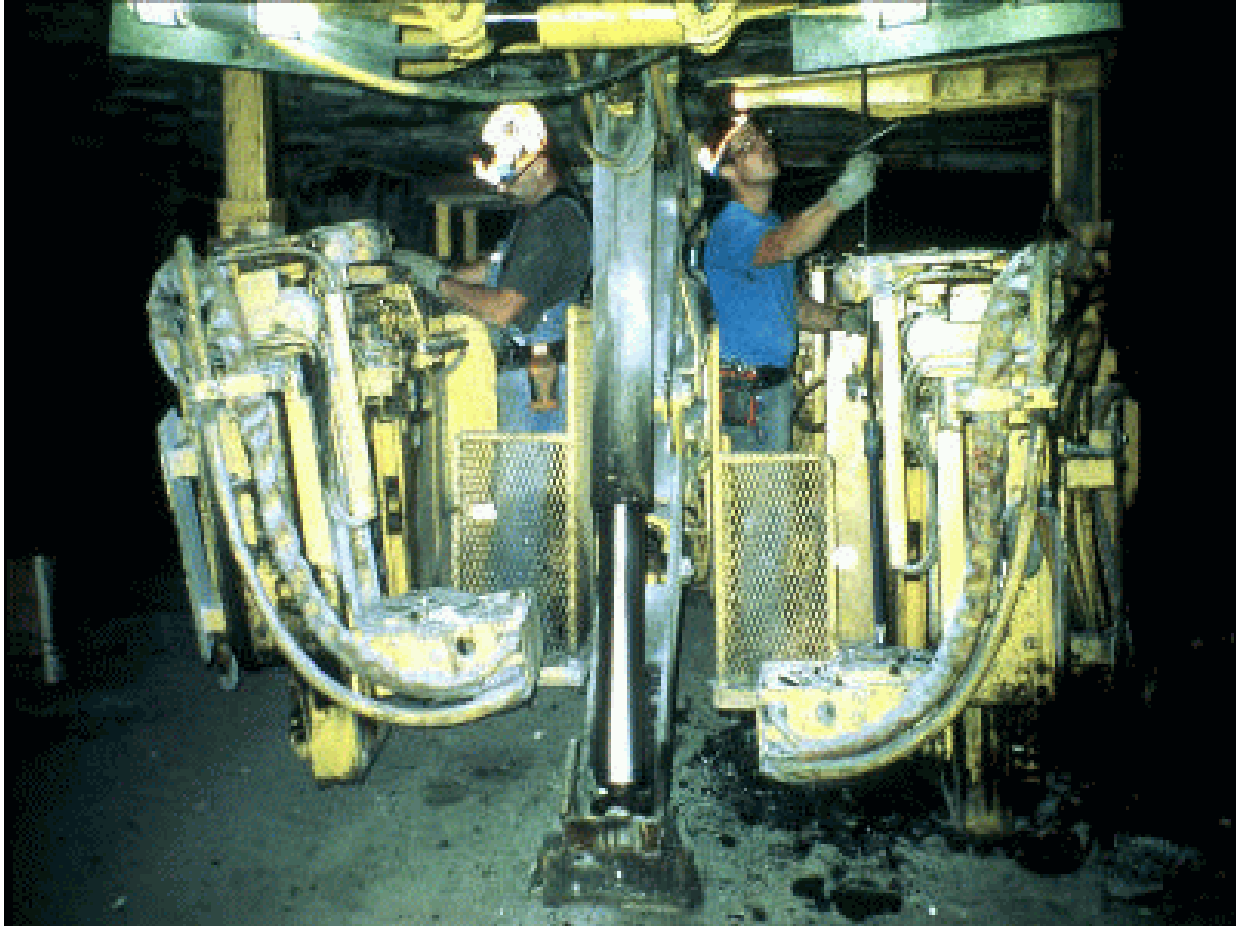
Figure 2. Workers roof bolting in a high seam mine.

In high seams (greater than 60 inches) workers often perform tasks from a platform on the bolting machine, as illustrated in figure 2. In general, roof bolting machine operators work in tight spaces. Roof drilling and bolt installation in underground coal mines is labor intensive, repetitive, and exposes operators to many hazards which can result in injury. In fact, drilling holes and installing bolts were reported as the leading sources of injury to roof bolting machine operators, accounting for 34.2 and 24.2 percent of accidents, respectively, based on an analysis of accidents in West Virginia [3]. This case study examined roof bolting injuries and associated activities at a high seam mine.
