RI 9432

Rock Mechanics Investigations at the Lucky Friday Mine

1. Instrumentation of an Experimental Underhand Longwall Stope

**By T. J. Williams, J. K. Whyatt,
and M. E. Poad**

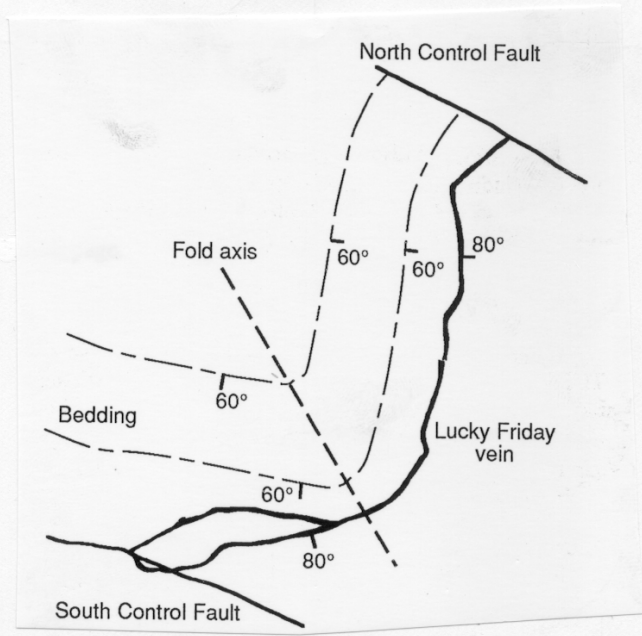
Figure 2.—LFUL geologic map.

The rock mass surrounding the vein is made up of beds of vitreous quartzite and sericitic quartzite from 12 to 36 in thick. Thin argillite beds are often found between quartzite beds. The vein itself contains massive galena, sphalerite, and tetrahedrite. Scott (10) provides an in-depth description of stope geology.

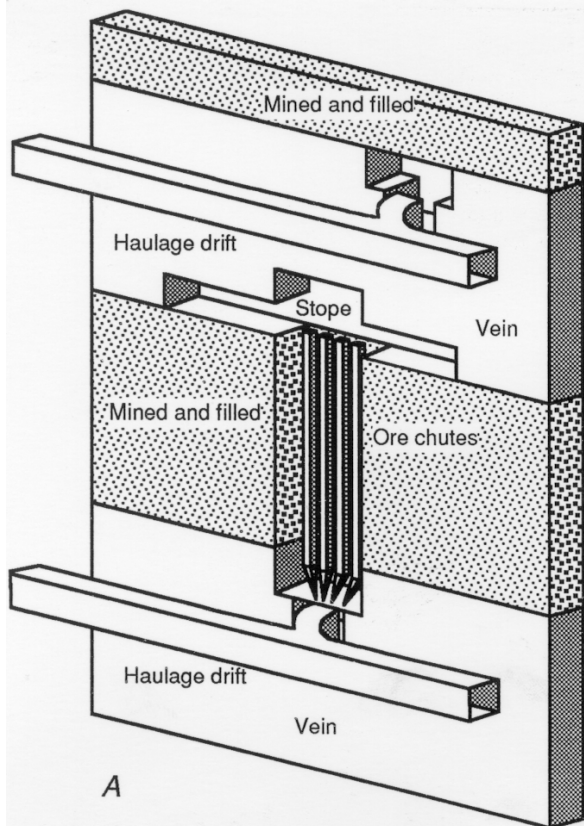
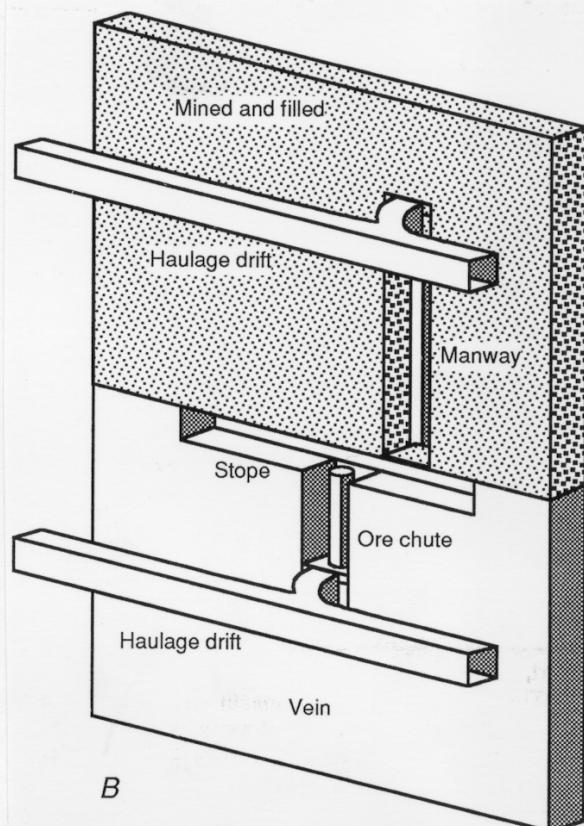
Figure 3.—Schematic of cut-and-fill mining methods. A, Overhand; B, underhand.

One characteristic of the overhand stoping method is that it produces a pillar of rock as mining proceeds toward previously mined areas above. Eventually, the entire pillar is removed. As the pillar becomes smaller, stress levels increase until the pillar fails or is completely mined out. Failure may be violent or nonviolent, depending upon the brittleness of the pillar and the relative stiffnesses of the pillar and wall rock. A nonviolent failure is characterized by gradual fracturing and yielding, while violent failure is characterized by the release of seismic energy. When sufficient seismic energy is produced to damage mine openings, the failure is called a rock burst.

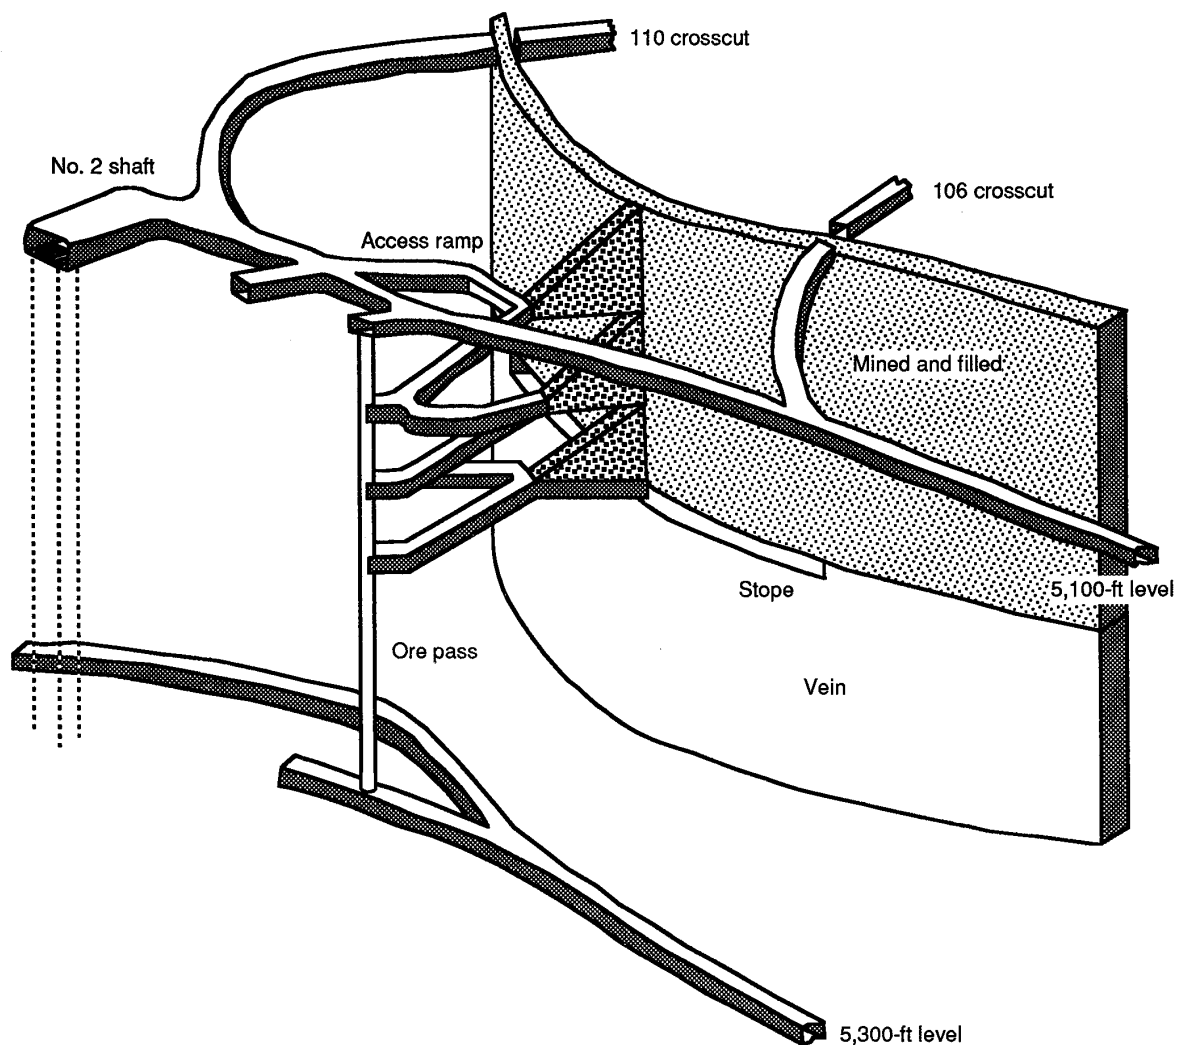
Figure 4.—Schematic of LFUL.

The LFUL stope uses conventional underhand cut-and-fill methods and a ramp system to provide access for mechanized mining equipment (11). Slushers are replaced with load-haul-dump equipment (LHD's), which in turn increase mucking efficiency sufficiently to allow stope lengths to be increased from 200 to 500 ft, thereby reducing the number of ramps required. Both 1/2- (in areas under 5 ft wide) and 1-yd³ LHD's can be used, depending on local vein width. In addition, all mining is organized on a single longwall to eliminate the formation of rock-burst-prone pillars. Figure 4 shows the resulting mining plan, as implemented in the experimental LFUL stope.

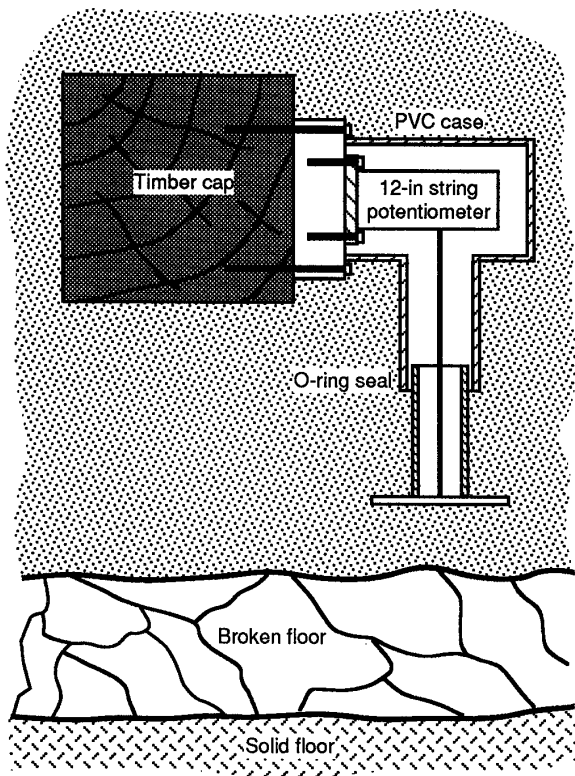
Figure 5.—Schematic showing sagmeter design and installation between mine floor and timber cap.

fill (especially cemented fill) is failing and is being held in place only by reinforcement members. Because mining made maintaining a reference point on the floor difficult, a sagmeter (fig. 5) was designed to measure displacement of the fill back between the bottom of the fill and a fixed 10- by 10-in timber cap installed across the middle of the stope. Measurements are taken with a string potentiometer protected by a telescoping tube. The bottom end of the tube is attached to a plate in the sandfill, and the top end is attached to the timber cap. The potentiometer and cables are mounted in the top of the instrument, away from blasting.

These instruments were not found to be useful. The cemented fill fractured more quickly and discretely than expected. Subsequent lateral shifts along these fractures damaged the instruments and their readout cables. Such conditions were not properly anticipated when the sagmeters were designed. In addition, when the fill reinforcement system was redesigned, the timber caps were removed, eliminating the sagmeter's stable reference point. Thus, measurement of sag was abandoned and back conditions were judged entirely by on-the-spot observations.

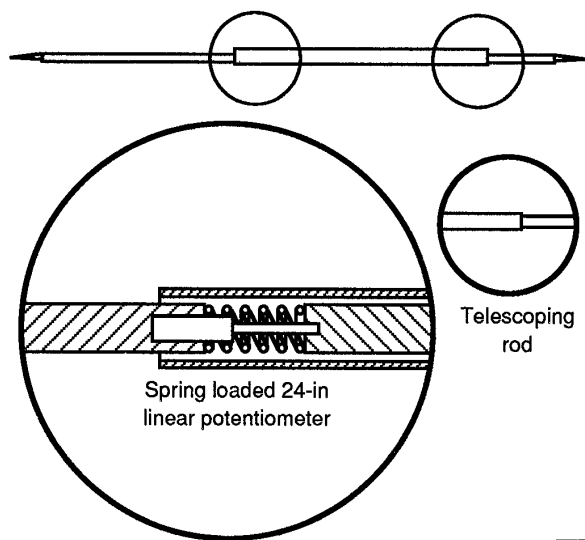
Figure 6.—Closure extensometer.

Fracturing and movement of the cemented backfill apparently broke either the housing or cables of most of the closure extensometers, although some survived excavation of the following cut. During the project, the housing was upgraded from plastic to aluminum, and extra coils of cable were left near the closure extensometer to allow for cable movement. However, only marginal improvements in instrument survivability were realized.

Of the 13 closure extensometers installed in the fill, 10 survived through excavation of one cut, two survived

through two cuts, and one through three cuts. Thus, the instruments proved to be suitable for monitoring one or two cuts, but failed to monitor long-term stope closure.

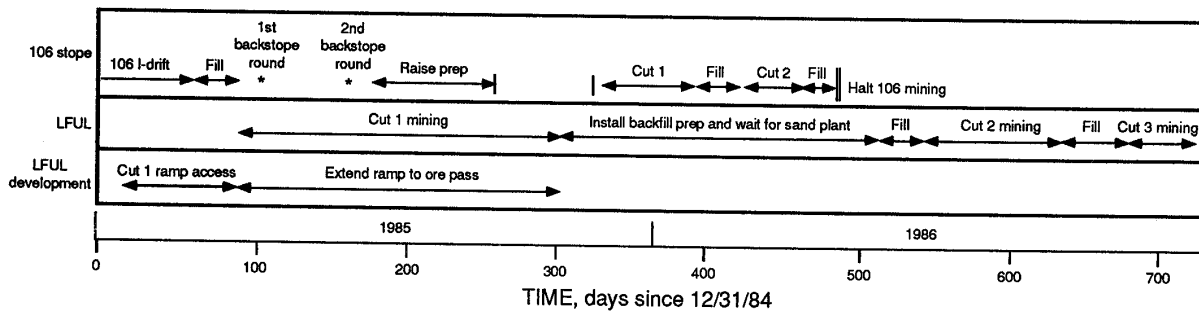
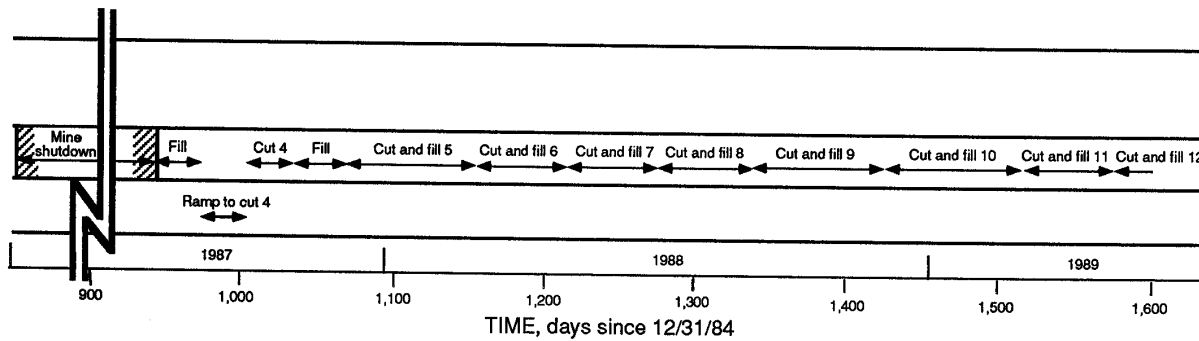
Figure 7.—Project timeline.

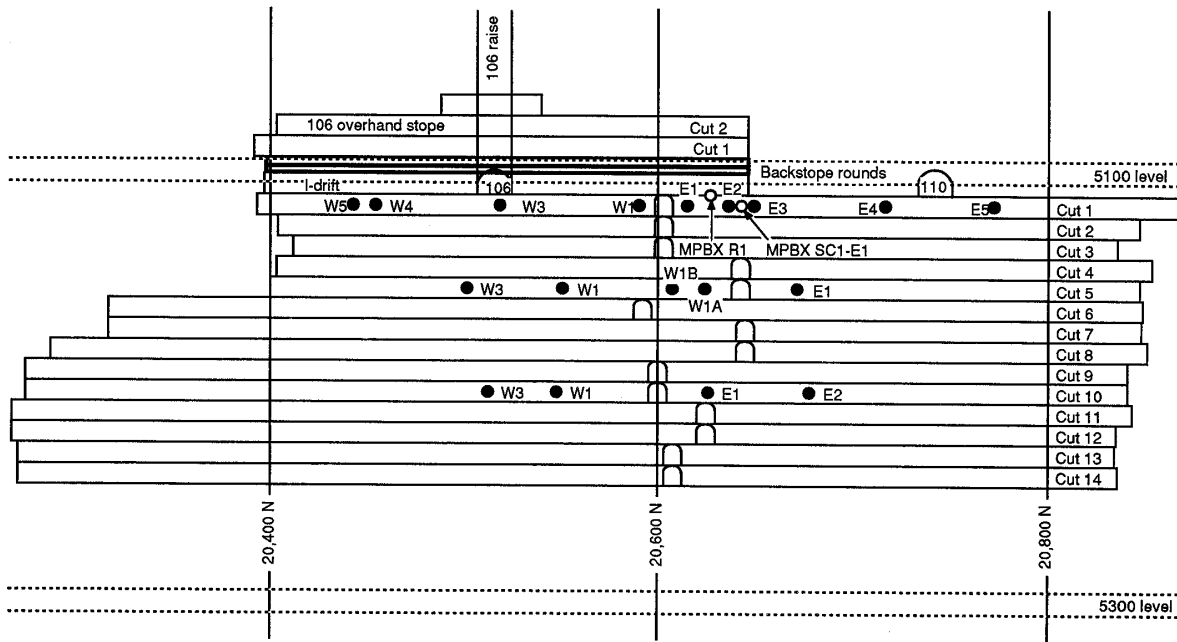
Figure 8.—Location of monitoring stations and excavation sequence for 106 and LFUL stopes.

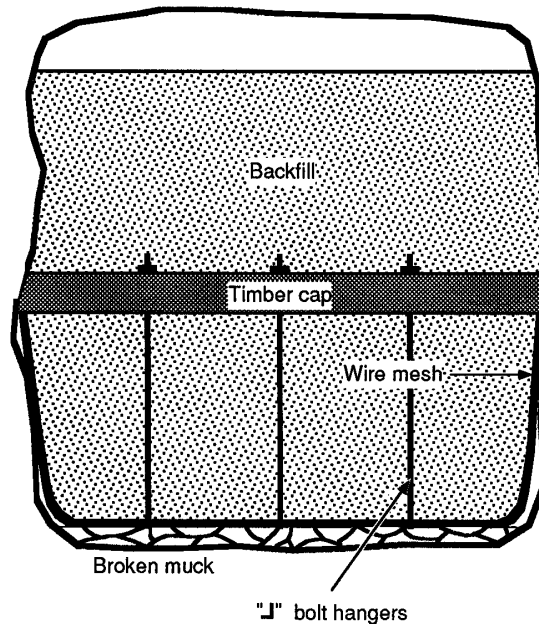
Figure 9.—106 I-drift fill reinforcement system.

rounds in 106, the I-drift was prepared to be backfilled as an underhand stope. Ten- by ten-inch caps were placed from wall to wall 3 ft off the floor, and wire mesh was hung at floor level from J-bolts and straps (fig. 9).

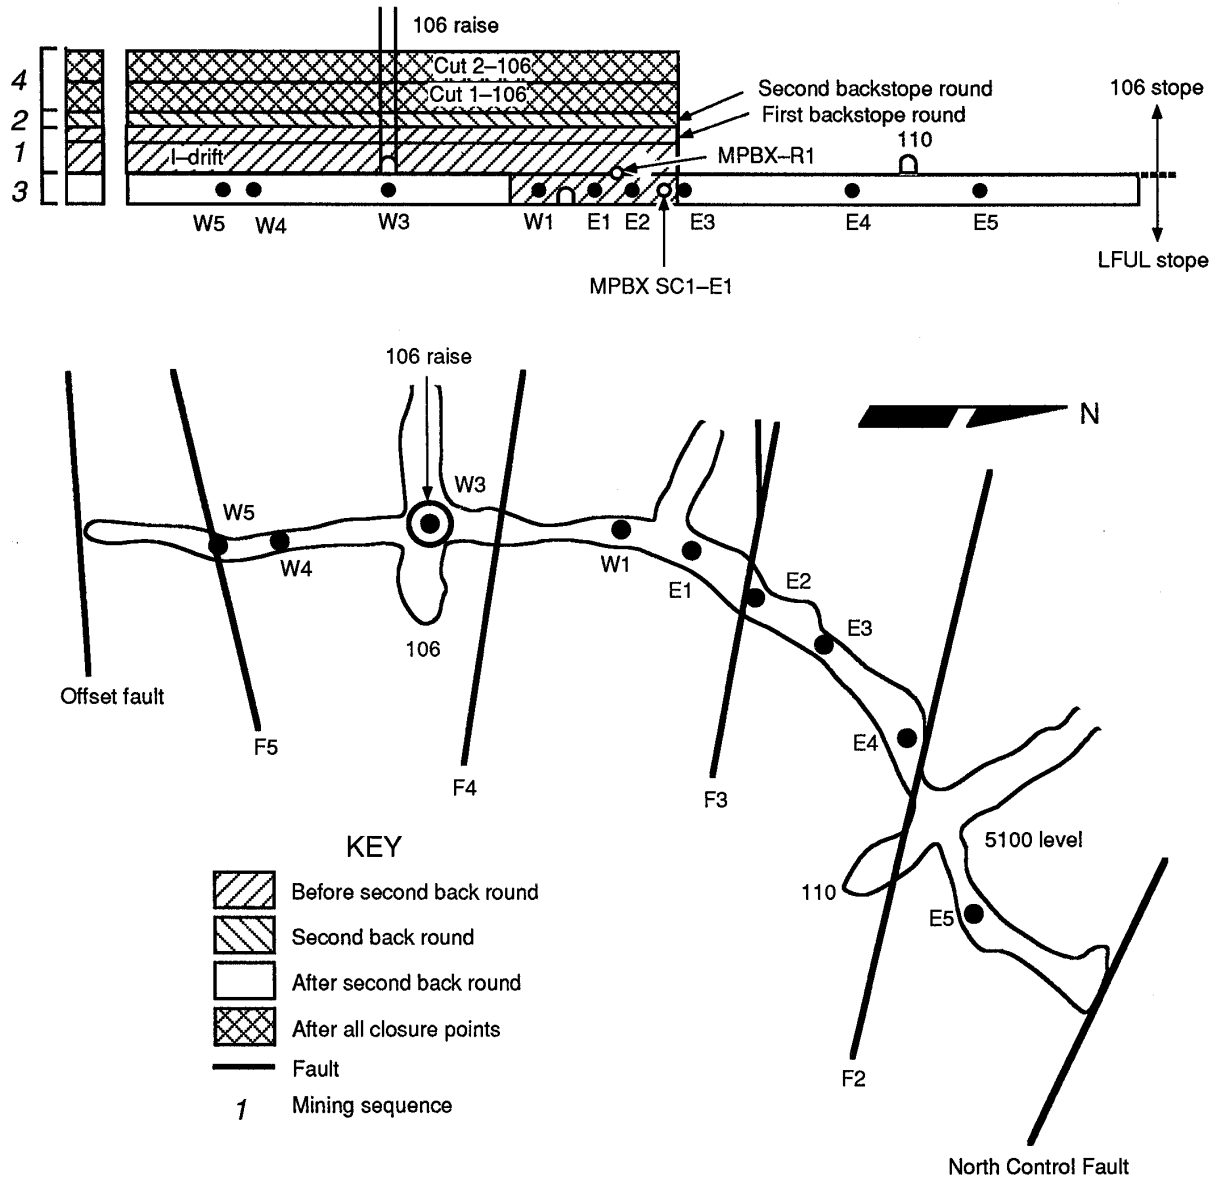
Figure 10.—Location of monitoring stations and MPBX's in cut 1 of LFUL.

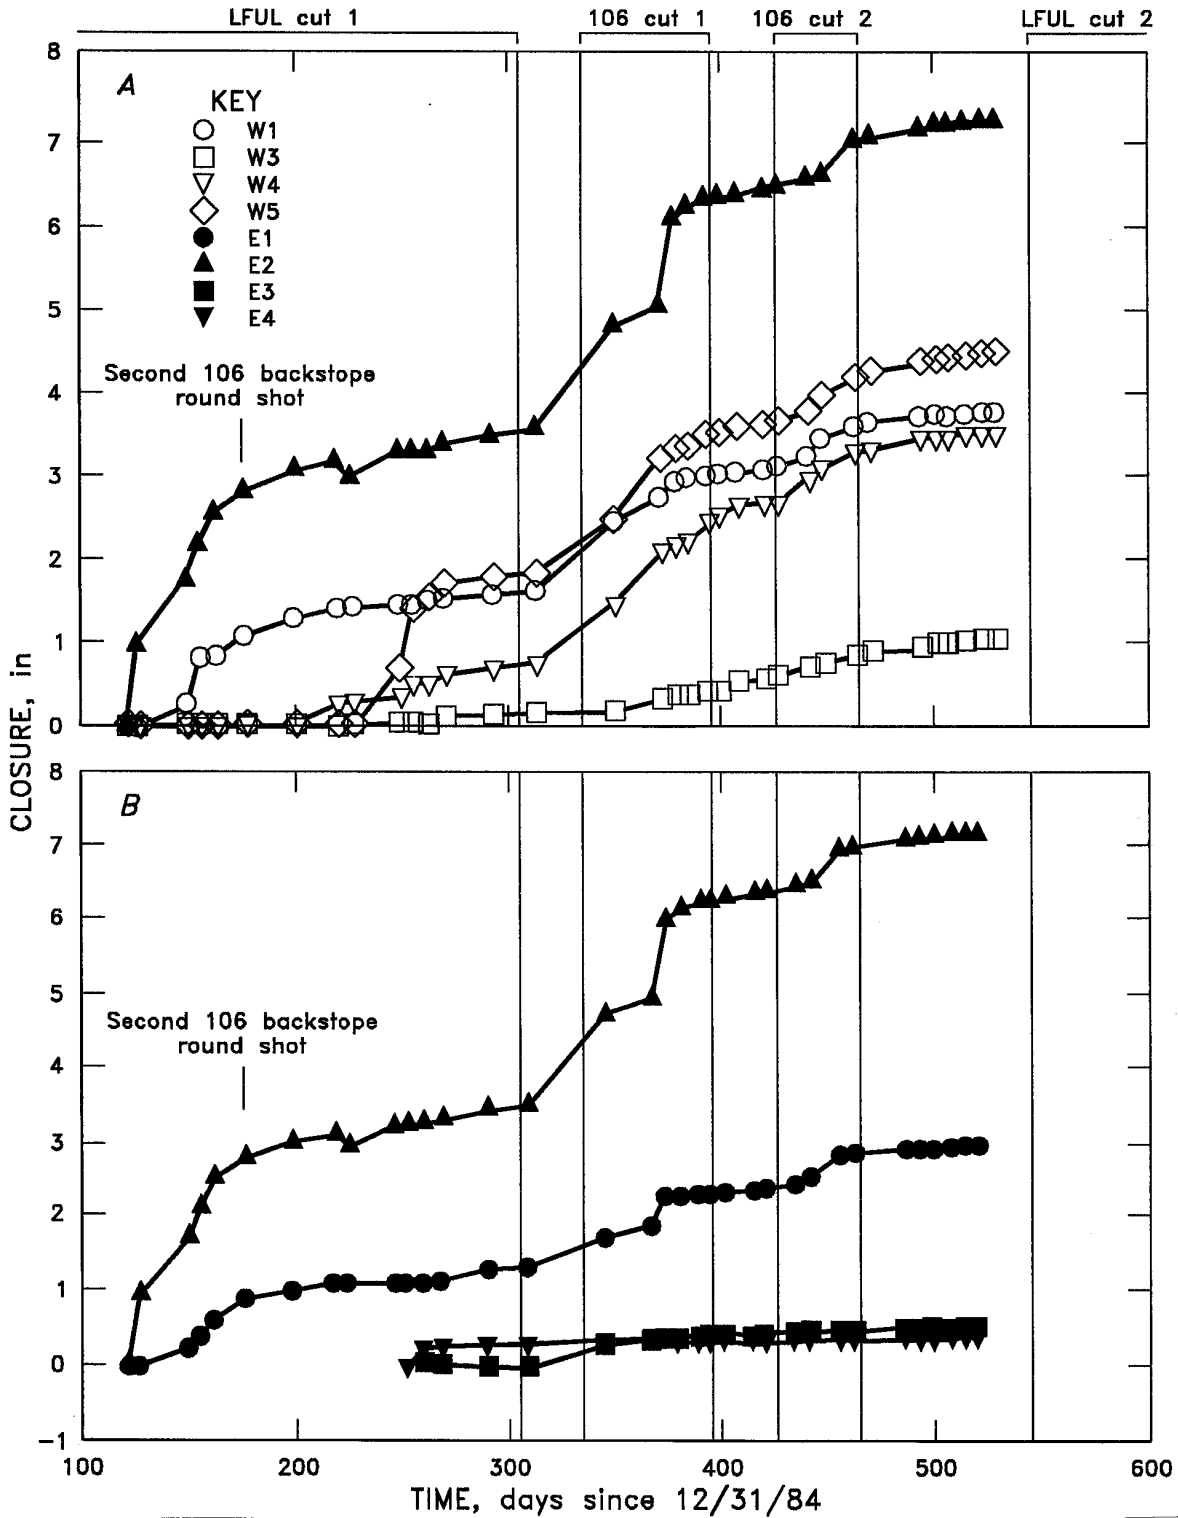
Figure 11.—Horizontal stope closure at monitoring stations in cut 1 prior to backfill placement. A, Stations west (W) of ramp; B, stations east (E) of ramp.

completion of the cut and mining of cut 2 in the 5100-106 stope above. Jumps in the closure rate after initial stabilization were attributed to mining of various 106 stope cuts. Closure at location E2 was nearly double that at other locations. This result may be related to the presence of a minor fault that crosses the vein at E2, stress concentrations associated with the bend in the vein (fig. 11A), and the end-line of the 106 stope directly above.

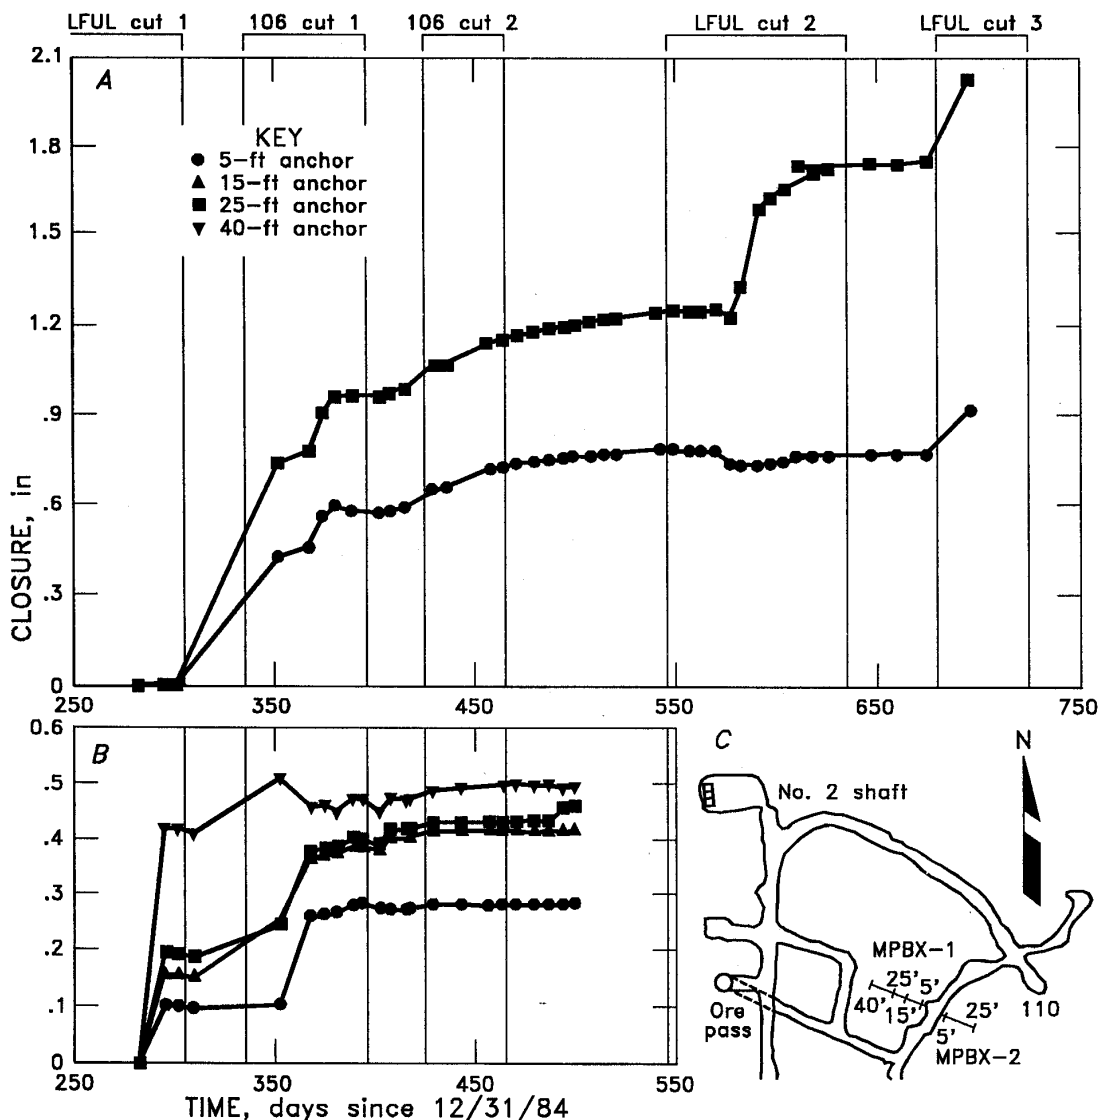
Figure 12.—Response of MPBX-2 (A) and MPBX-1 (B) to cut excavation. Location of MPBX's (C).

south wall was converging and fracturing more rapidly than the north wall (fig. 12) as cut 1 was finished. This phenomenon was visually evident and agreed with data collected by the mine-wide microseismic system (16), which indicated that most seismic activity and fracturing were occurring in the south wall. The seismicity pattern in the south wall did not appear during subsequent cuts, and an explanation for this pattern was never established.

MPBX-2 (fig. 12) showed that fractures between the stope wall and the 5-ft anchor were compressed while fractures between the 5-ft anchor and the 25-ft anchor opened. Apparently, the loose rib rock was subjected to confining pressures as fracturing rock expanded deeper in the wall.

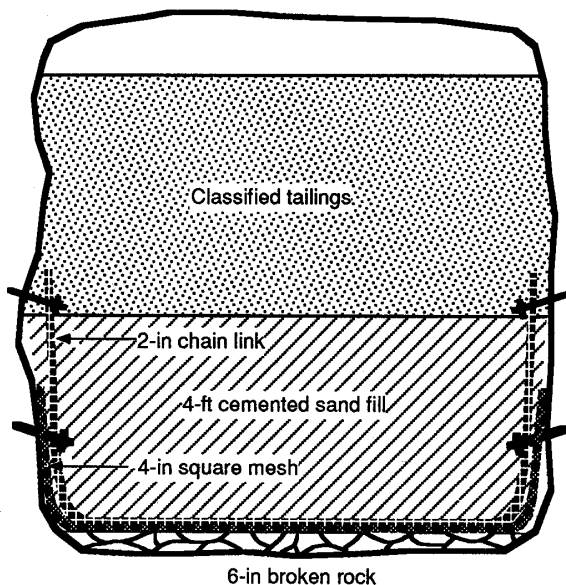
Figure 13.—Schematic of fill support system.

above. The LFUL stope was prepared for sandfill placement by drilling holes in the wall at floor height, from which 1/2-in wire cable slings were installed from wall to wall (fig. 13). A wire mesh mat was laid over the cables. Engineers at Hecla Mining Co. (2) conducted pull tests of cable wedged into Split-Set rock bolts to evaluate the load-carrying capacity of the anchor. It was found that a typical cable held 8,000 lb of load before sliding out of the Split-Set anchor. Since actual loading direction in the LFUL stope is at an angle to, instead of parallel to, the Split-Set,

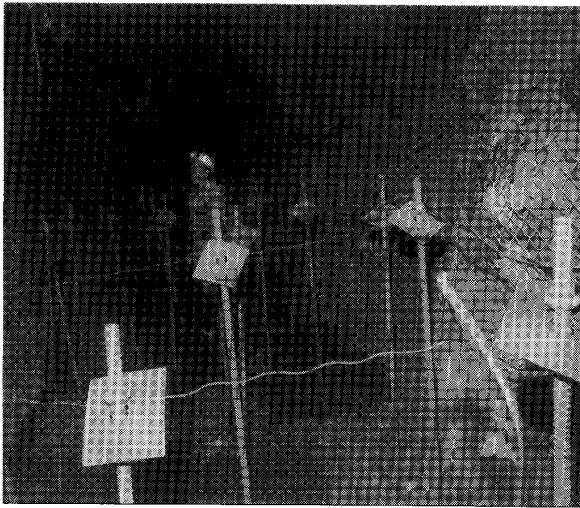
Figure 14.—Preparing Dywidag bolts for sandfill.

A mine shutdown in January 1987 provided mine engineers with an opportunity to modify the fill reinforcement system by replacing cable slings with 6-ft-long Dywidag bolts. These bolts were installed vertically on 2- to 3-ft centers and behaved in a manner similar to rebar in concrete (fig. 14). The bottom end of each bolt was driven through wire mesh into loose muck on the floor. (The wire mesh was eventually eliminated in later cuts without any problems.) A nut and a plate were then placed on the top of the bolt to serve as an anchor in the fill. As the next cut was mined, the bottom ends of the bolts were exposed. At this time, a second set of plates and bolts were installed to tension the rebar and provide anchors for fencing. Fencing extended along the entire back and down the stope walls to within 1.5 ft of the bottom. Split-Set bolts were used to fasten the fencing to stope walls. The fencing protected miners from fly rock and localized rock bursts (fig. 15).

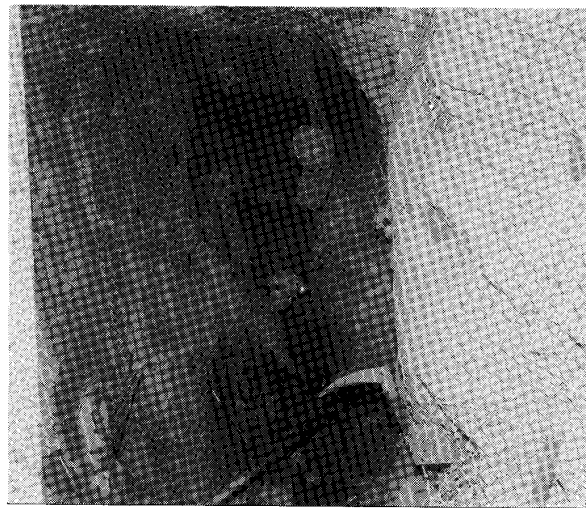
Figure 15.—Hanging chain link fencing for overhead protection.

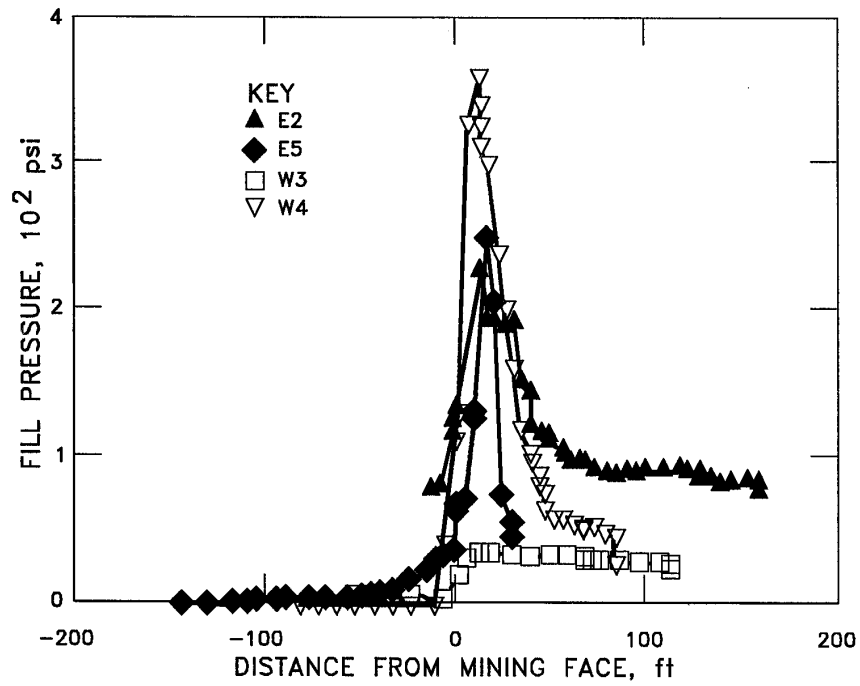
Figure 16.—Response of pressure cells in cut 1 to mining in cut 2.

Pressure cells monitored support pressure development as mining proceeded past each cell. Three of the four cells recorded substantial pressures when the mining face was 10 ft away horizontally; these pressures peaked when the face was 15 ft past and dropped off sharply with further mining, indicating fracture of the cemented fill (fig. 16). Fracturing was then confirmed by visual inspection. The fourth pressure cell (W3) was located in the upper uncemented portion of the fill. This cell showed a much smaller increase in pressure and no degradation of pressure as the underlying cemented fill fractured. The pressures measured in the cemented fill after fracturing were surprisingly similar to those measured in the uncemented fill.

Three of the pressure cells survived mining of the third cut. The two installed near the center of the stope showed increases of 40 to 70 psi, while the cell near the end of the stope showed increases of only 10 psi. This difference may have indicated a void at the top of the fill above the third cell, or greater closure towards the middle of the stope, as would be expected in an elastic rock mass.

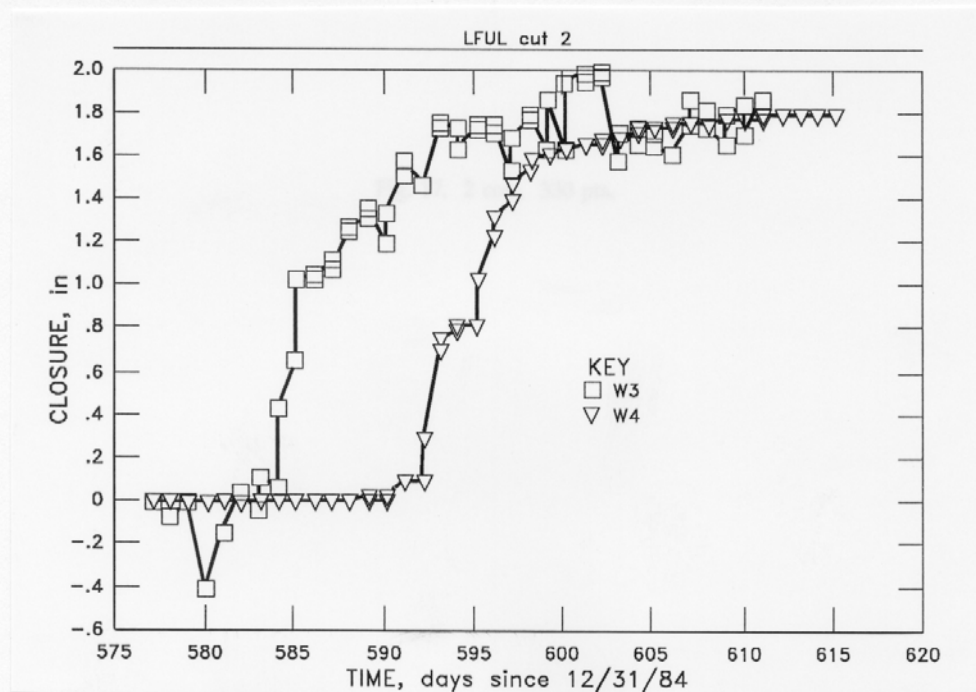
Figure 17.—Response of closure extensometers in cut 1 to mining in cut 2.

Closure in the fill above mining clearly depended on the progress of mining in cut 2 (fig. 17). The closure extensometers in the 106 raise, which were farther removed from mining, showed a more gradual response (fig. 18).

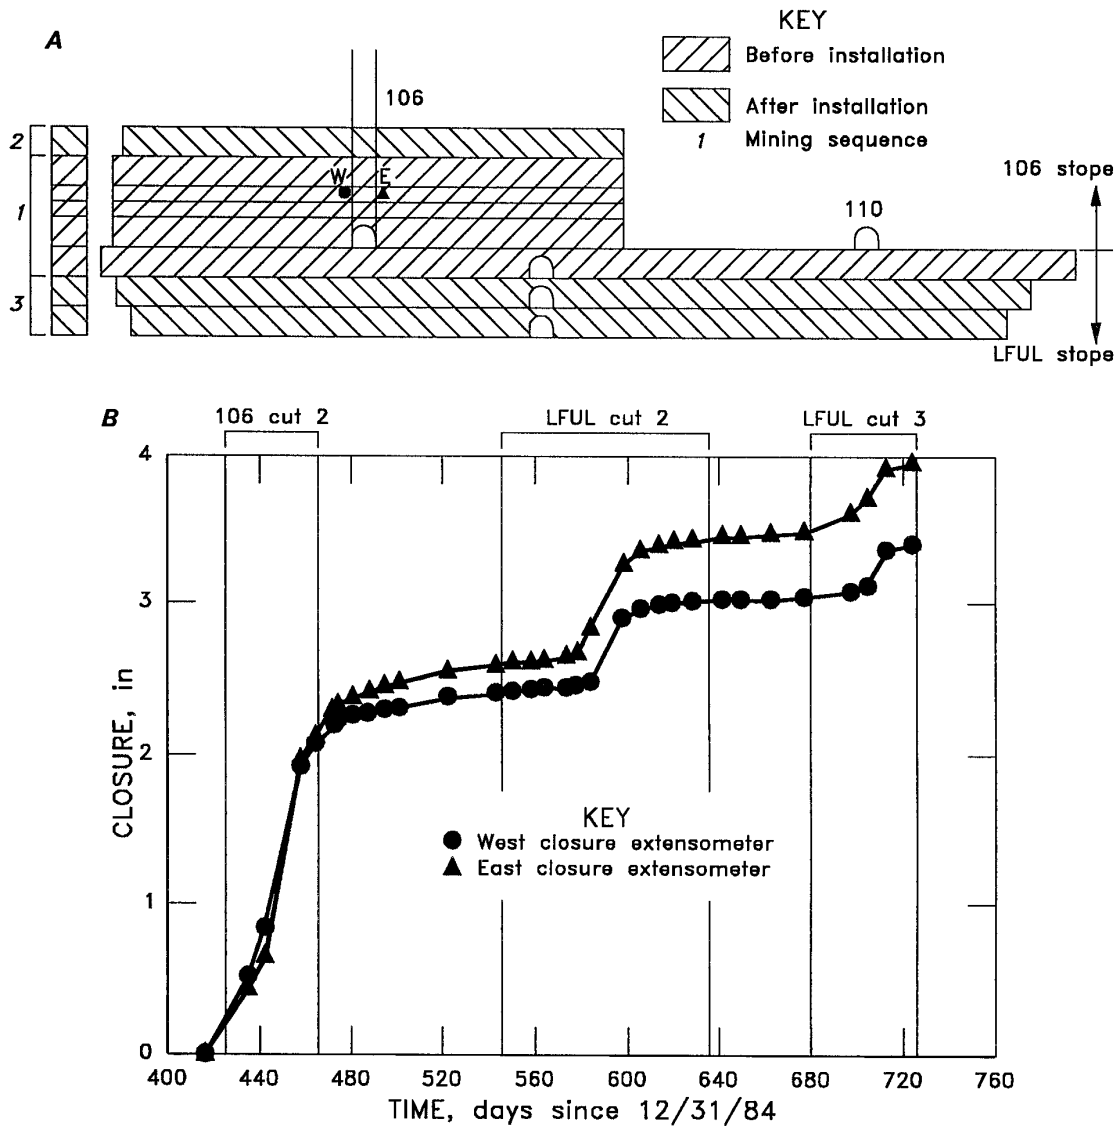
Figure 18.—Excavation sequence in 106 and LFUL stopes (A); response of closure extensometers in 106 stope to mining in LFUL stope (B).

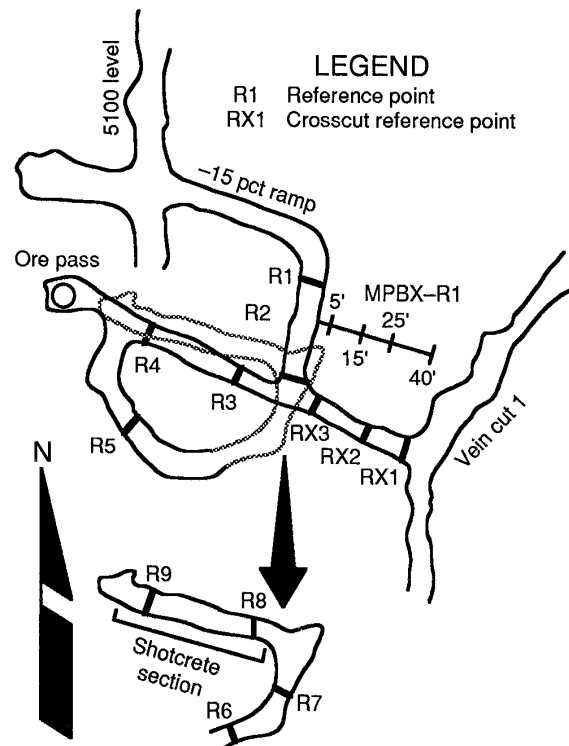
Figure 19.—Location of ramp (R1 to R4) and ramp crosscut (RX5 to RX9) monitoring stations.

Reference points were installed at R1 to R9 in the main ramp spiral as it was driven for manual measurements of ramp closure. Measurements at R1 and R5 to R9 showed quick stabilization (fig. 20), but measurements at R4, and to a lesser extent, R2 and R3, showed significant amounts of closure prior to stabilization. Apparently, points at R2, R3, and R4 were located in a weaker portion of the rock mass, probably near a fault that runs through the ramp haulage section and the ore pass. This interpretation is supported by raveling of the ore pass adjacent to R4 encountered during stope development.

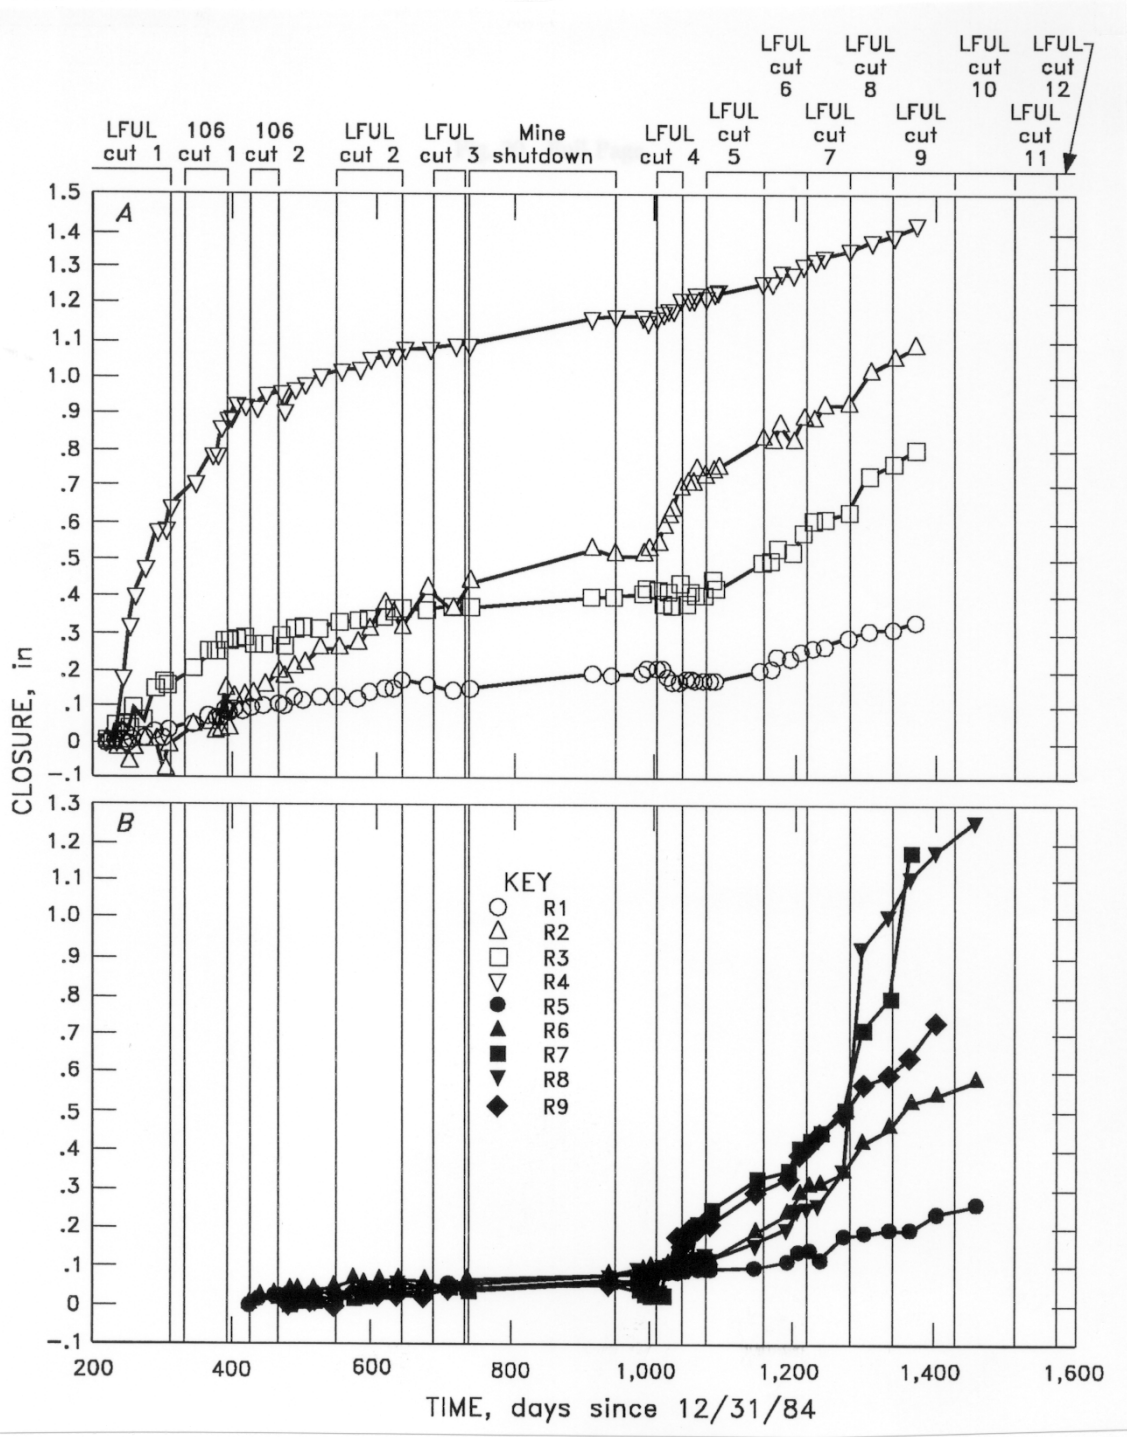
Figure 20.—Closure measured at ramp monitoring stations during mining. A, RX1 to RX4; B, RX5 to RX9.

Closure measurements were continued in the ramp after initial stabilization to check the response of the ramp to mining in the LFUL stope. In general, only the portions of the ramp nearest the stope (R2, R3, R6, R7, and R8) showed any change. This was especially evident for closure measurements in the second ramp spiral (R6, R7, and R8), which were quite small until mining reached cut 4, the first cut to use the second ramp spiral.

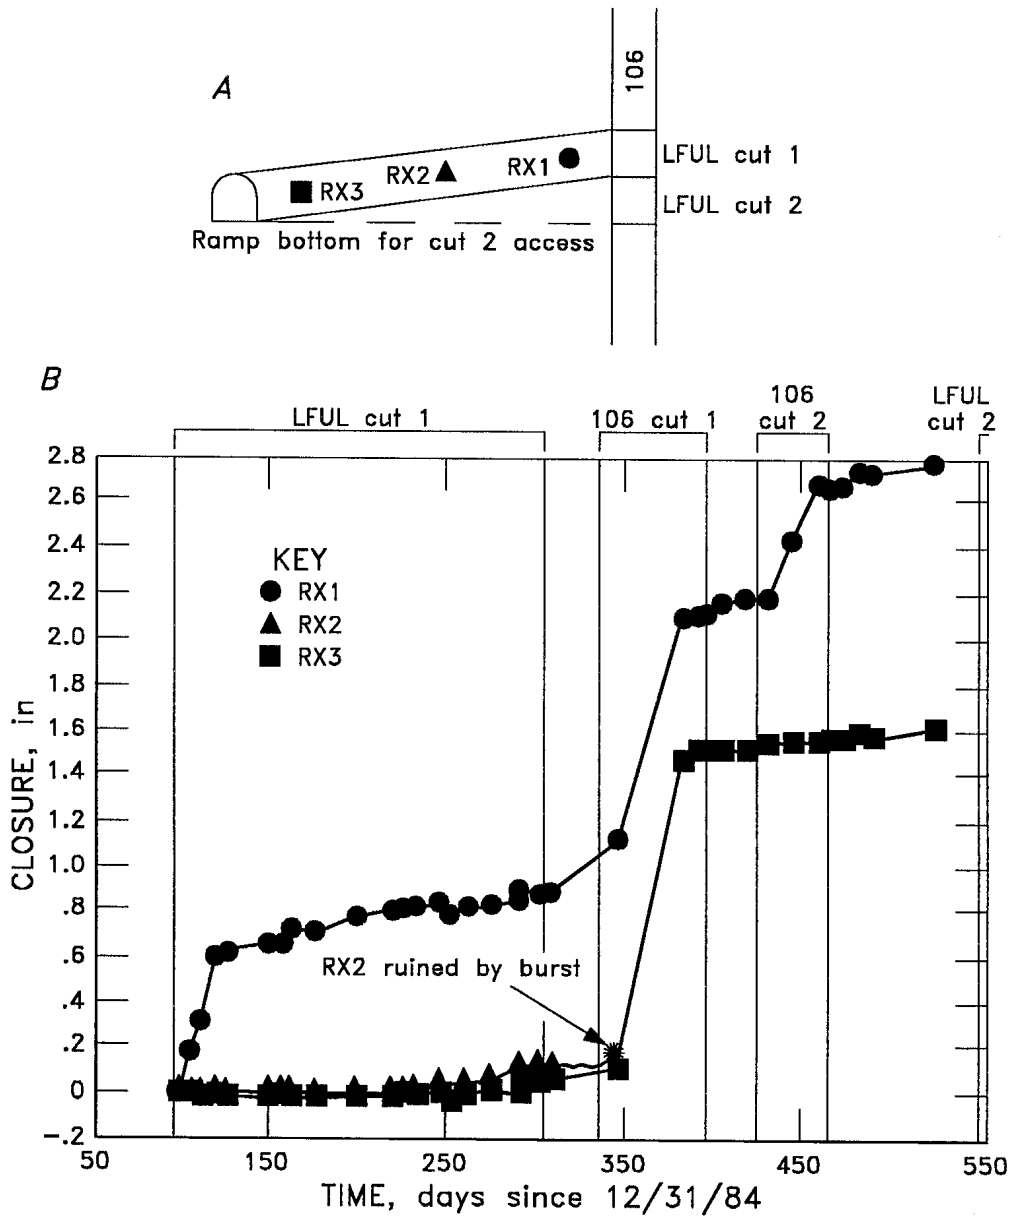
Figure 21.—Location of monitoring stations in ramp crosscut (A) and measured closure (B).

Three reference points at RX1, RX2, and RX3 were established in the crosscut between the spiral ramp and the vein to measure closure during mining of the first cut of the LFUL stope (fig. 21). RX2 was lost to a rock burst just after this cut was completed, but the remaining reference points were available for measuring crosscut closure associated with mining in the 106 stope above. These points were lost when the crosscut ramp was deepened to access the second cut of the LFUL stope.

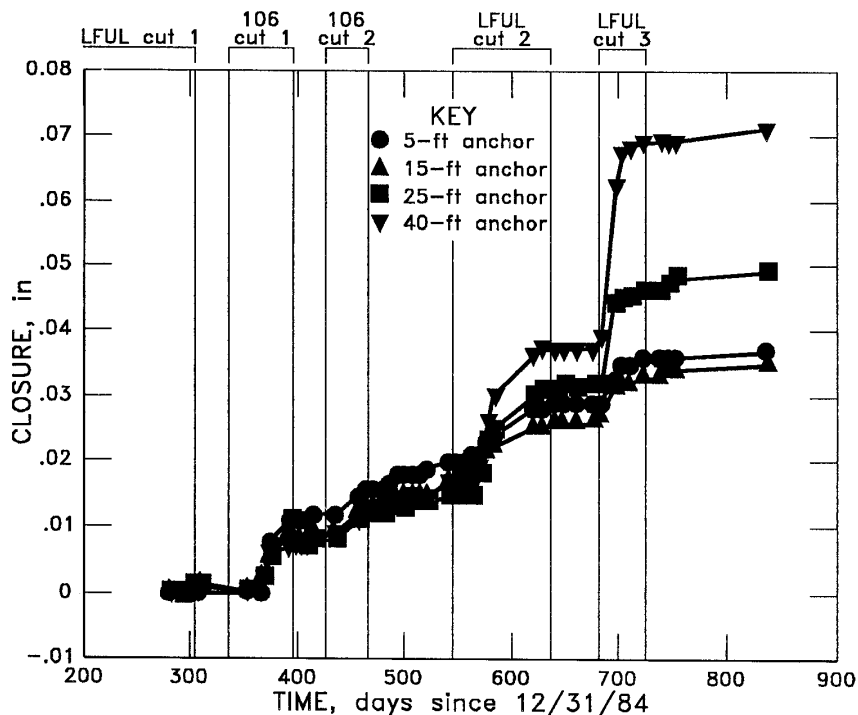
Figure 22.—Response of MPBX-R1.

MPBX-R1 was installed in the wall of the ramp near the LFUL stope just after excavation of the first cut of the LFUL stope. The purpose was to monitor the stability of the pillar between ramp and stope (fig. 22). Measurements were taken during mining in the 106 stope as well as the second and third cuts in the LFUL stope. The relative movement measured between anchors suggested minor inelastic deformation of rock between the 15-, 25-, and 40-ft anchors, which were nearest the stope, and between the collar (at the ramp wall) and the 5-ft anchor next to the ramp. The remaining portion of the pillar between the 5- and 15-ft anchors was very stable. The small magnitude of these displacements, less than 0.1 in, indicated a stable ramp pillar.

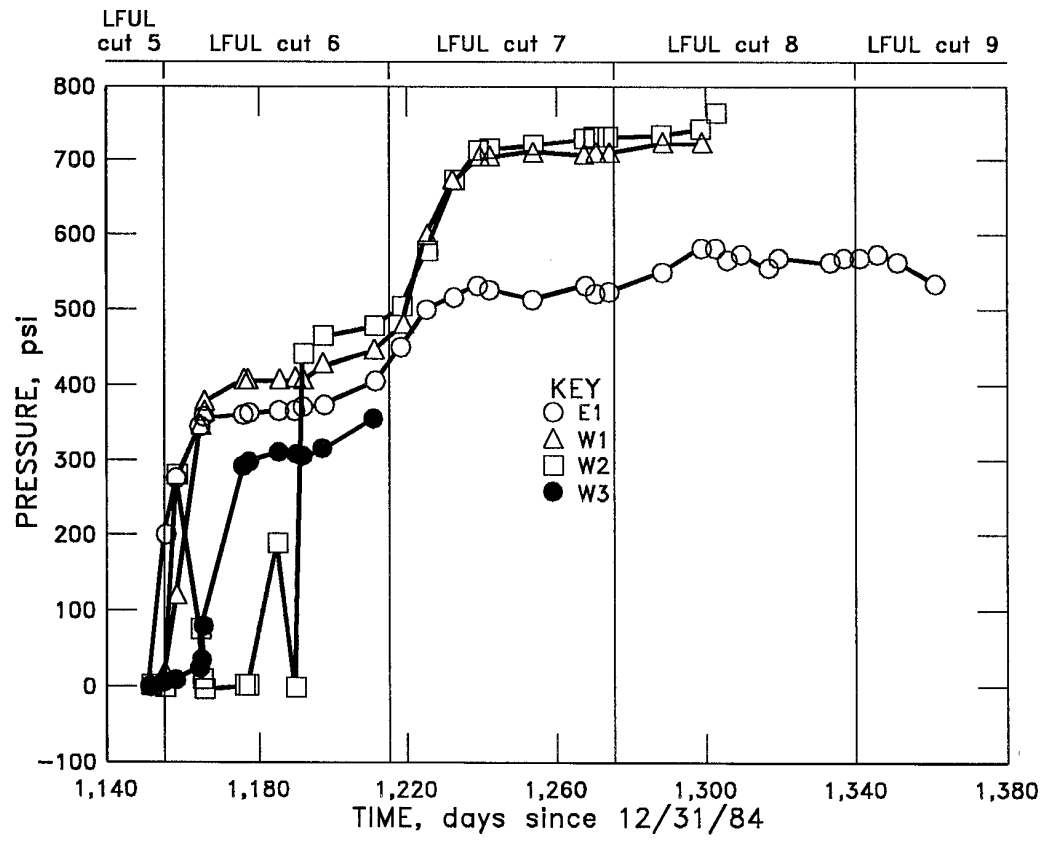
Figure 23.—Response of pressure cells in cut 5 to mining in cuts 6 through 9.

All four pressure cells (fig. 23) showed an increase in pressure between 300 and 400 psi during mining of cut 6, but failed to survive excavation of cut 7. Three of the four corresponding stope closure extensometers survived backfilling to record closure during mining of cut 6 (fig. 24). These instruments showed wide variations in the amount of stope closure between locations (1 to 3 in) and did not vary in concert with fill pressure measurements. This lack of correlation suggests that fill properties continued to vary widely within the stope.
