RI 9432

Rock Mechanics Investigations at the Lucky Friday Mine

1. Instrumentation of an Experimental Underhand Longwall Stope

**By T. J. Williams, J. K. Whyatt,
and M. E. Poad**

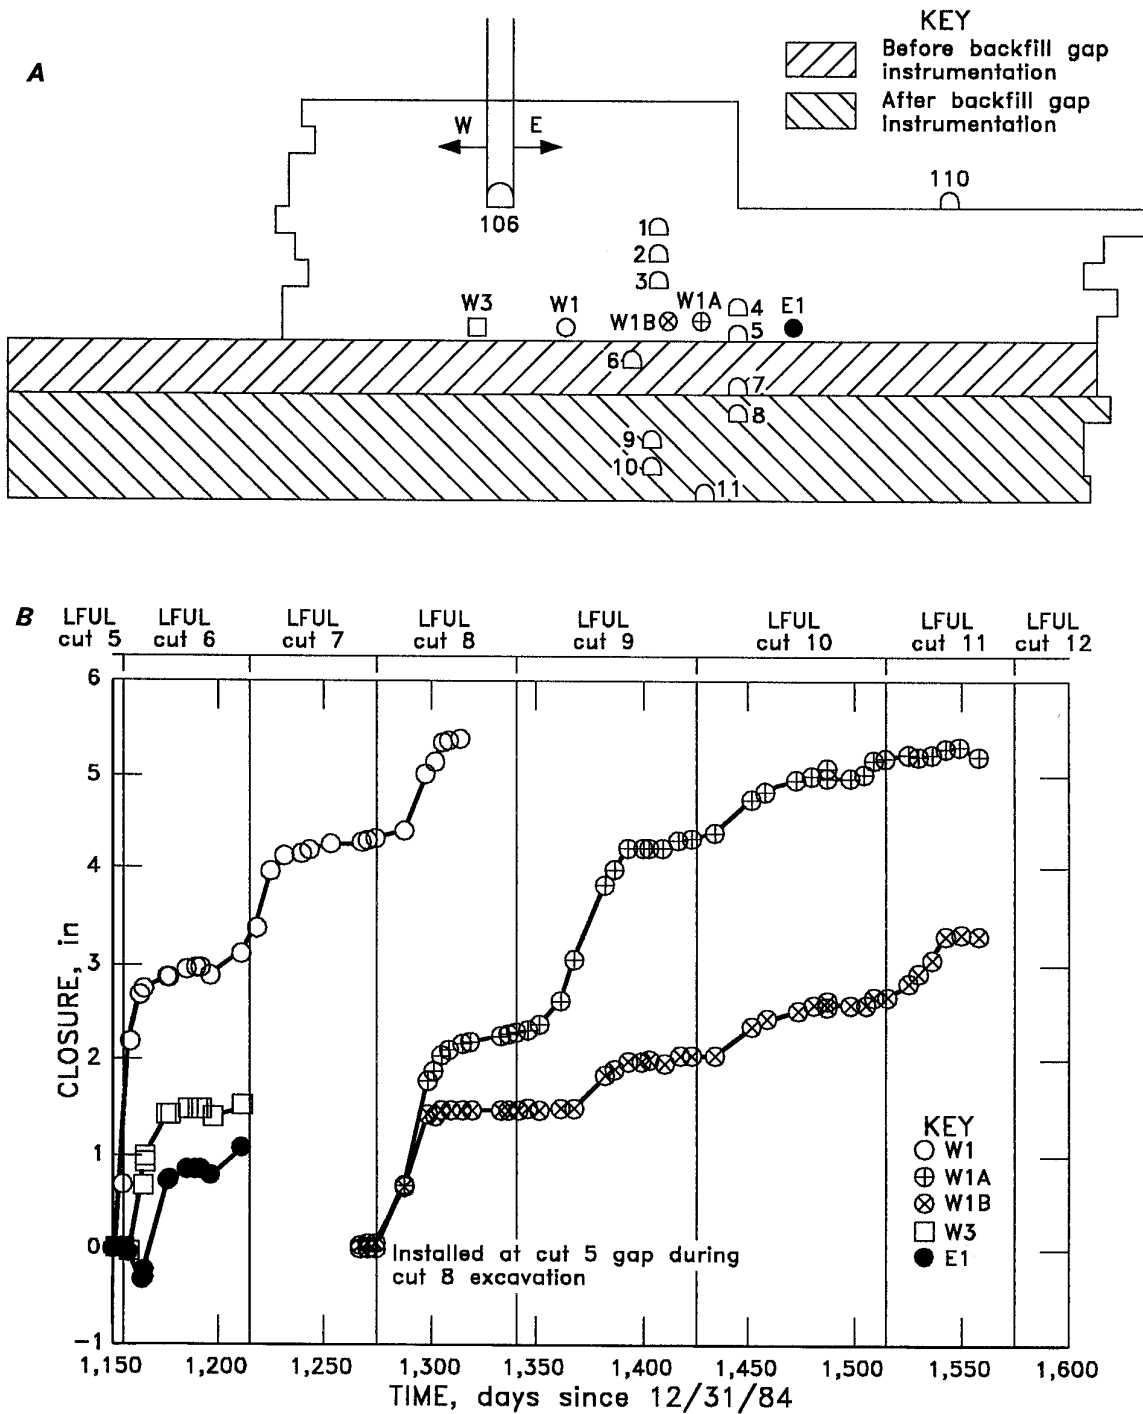
Figure 24.—Location of slope monitoring stations (A) and measured closure (B) in cut 5 to mining in cuts 6 through 12.

The closure extensometer at W1 survived to monitor excavation of cuts 7 and 8, showing reduced, but still significant, closure with each cut. Visual inspection of backfill in the stope (possible through an unfilled portion of the ramp crosscut) just prior to excavation of cut 8 showed cut 5 fill was buckling up into the gap between stope fill levels (fig. 25). Two additional closure extensometers were installed at this time at locations W1A and W1B, between W1 and the ramp crosscut at cut 5. These closure extensometers survived mining of cut 8 through part of cut 11 and indicated continued closure at significant, but declining, rates with mining (fig. 24). These measurement readings reinforced the pattern of local variation in closure registered by the extensometers placed in cut 5 fill.

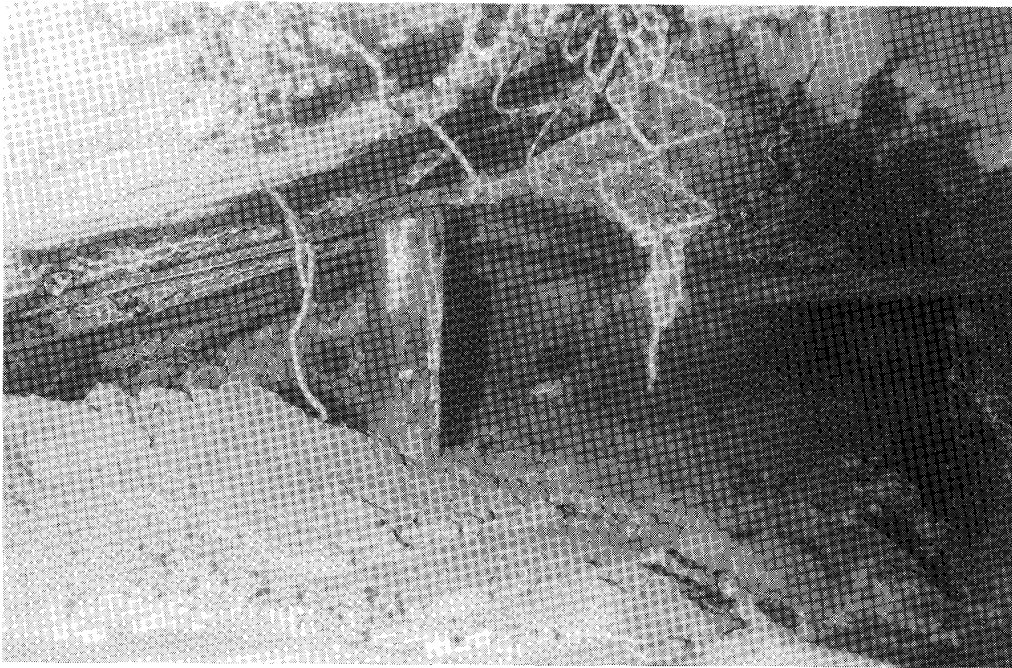
Figure 25.—Gap above sandfill in cut 5.

The final set of four closure extensometers and six pressure cells were installed in cut 10. The fill buckling and continued high rate of closure in cut 5 led researchers and mine staff to discuss ways to improve the speed at which support pressure could be generated in the fill. The easiest way appeared to be filling the stope as tight to the back as possible, hastening the attainment of fully confined conditions. With significant extra effort, miners were able to fill to within an average of 6 in of the back.

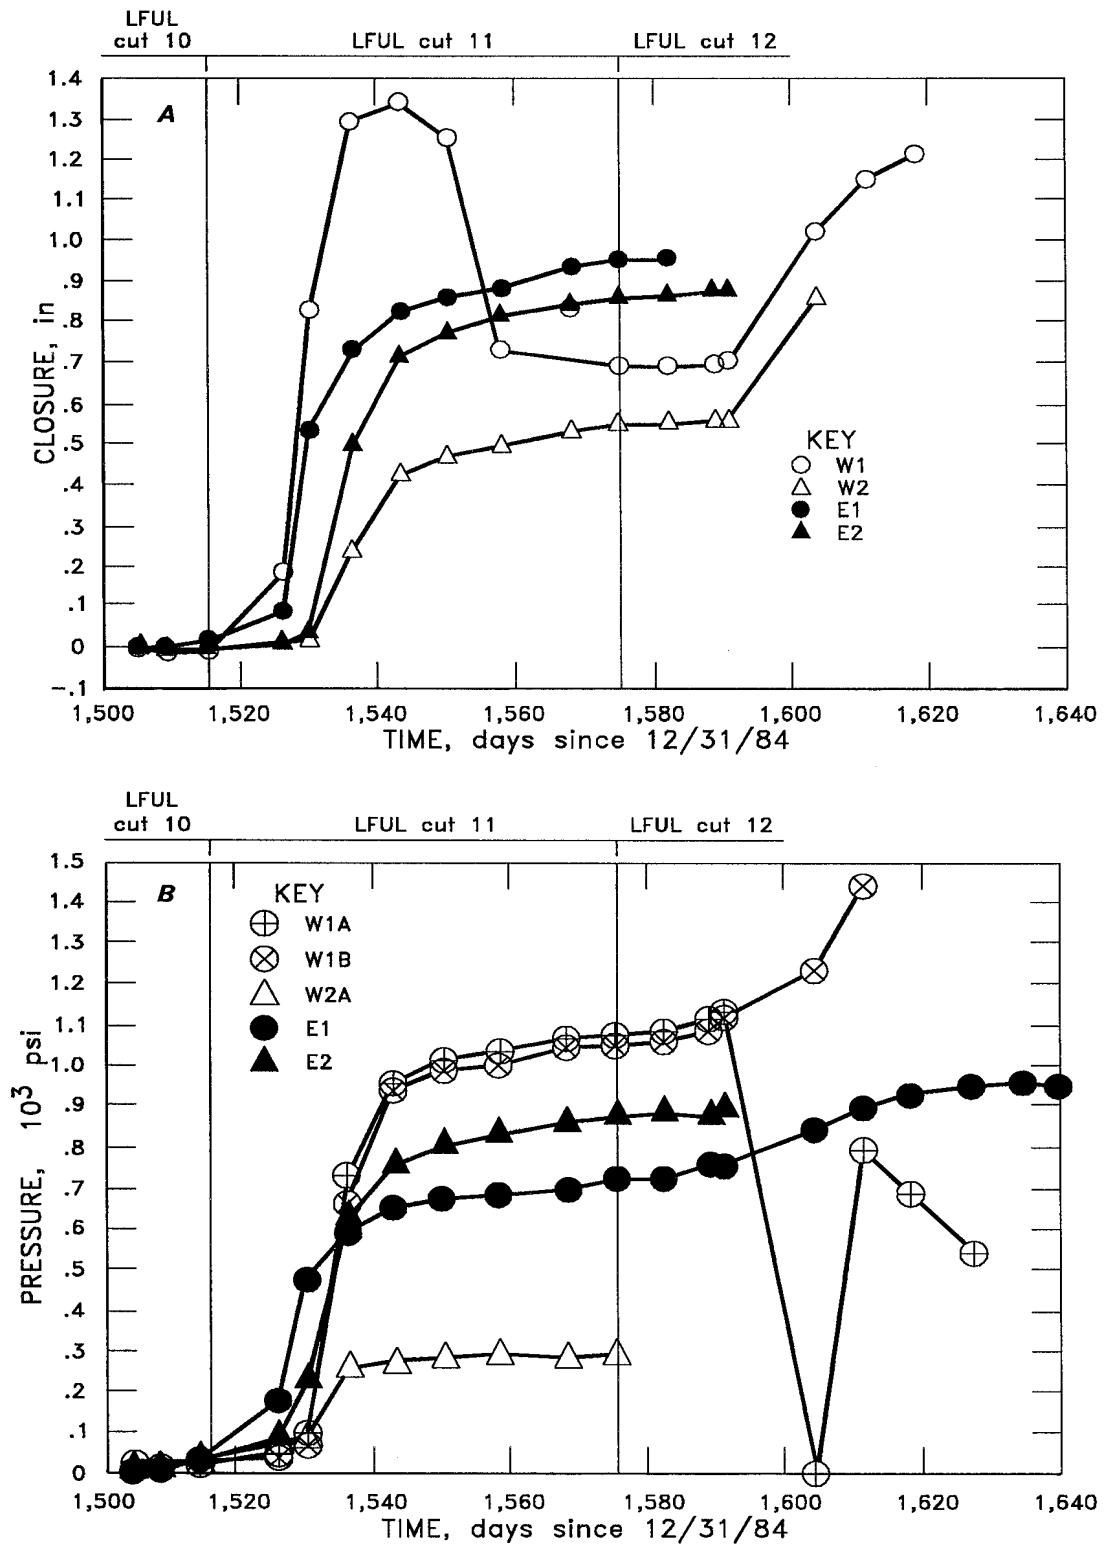
Figure 26.—Response of closure extensometers (A) and pressure cells (B) in cut 10 to mining.

modest stope closures averaging less than 0.8 in. in response to mining of cut 11 (fig. 26A). The pressure cells (fig. 26B) showed generally impressive support pressures after excavation of cut 11. Four of the five pressure cells measured 600 to 1,000 psi. The lowest pressure, measured at W2A, registered nearly 300 psi, which was in line with the average pressure generated in cut 5 and may have been the result of a localized void. Thus, support pressure measured by all five cells averaged 800 psi. These instruments failed either during filling of cut 11 or early in the excavation of cut 12; pressure cell W1B measured a peak pressure of over 1,400 psi before it failed during excavation of cut 12.
