CRANE FALL HAZARD ABATEMENT AT NAVAL INVENTORY CONTROL POINT (NAVICP) MECHANICSBURG, PA

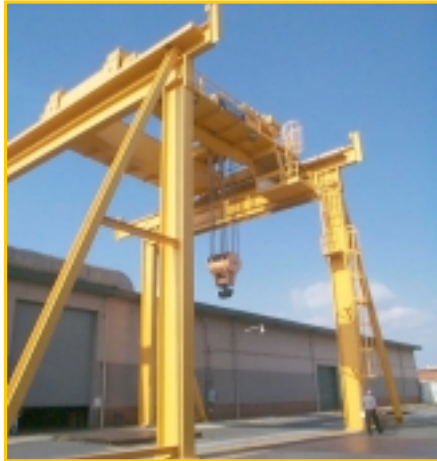
NAVICP's 60-foot high 400-ton bridge crane

The 60-foot high, 400-ton stationery bridge crane was especially important to the engineers and the NAVICP Safety Department. Crane inspectors and mechanics were at risk of falling from heights while climbing up to and down from the trolley platform on the crane's top deck and while working on that platform. Although the inspectors and mechanics always wore fall arrest gear when on the platform, the crane had only one approved point for anchoring their fall arrest equipment, allowing for only a very limited and obstructed working area.

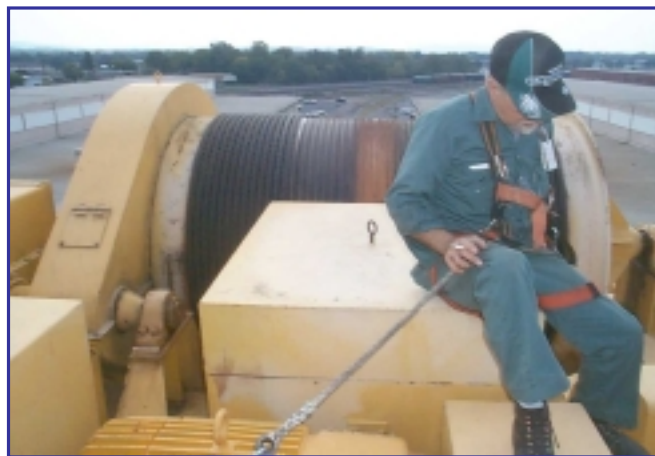
One anchor point for fall arrest gear resulted in very limited working area

Safety industry engineers, Navy Crane Center maintenance personnel and operators, and two Navy Public Works Mechanicsburg crane inspectors, Dick Hartung and Mark Richardson collaborated on the development of designs for a cost-effective solution to the bridge crane hazards that would also comply with OSHA and the Navy Crane Center's strict safety requirements. The solution included installation of catwalks, with both permanent and removable guardrails, ladder cages, and protective access covers for rotating equipment

such as winch drive shafts.

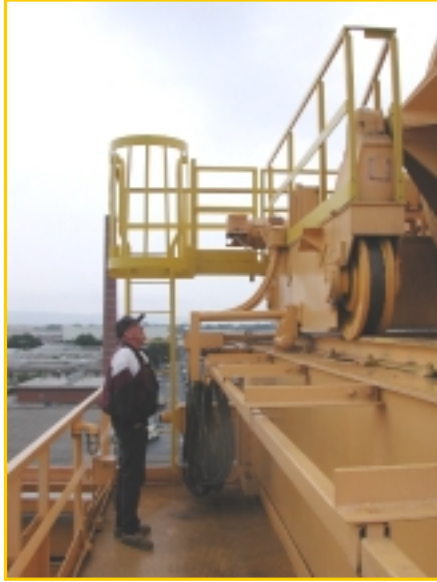
Safety guardrails installed on bridge crane prevent falls

After the Navy Crane Center and NAVICP Safety and Public Works performed the final condition inspection, the crane's operational tests were performed by Mr. Hartung and Mr. Richardson. This completed inspection and approval of the bridge crane remediation. The bridge crane also passed its annual recertification inspection.
