The Submarine Division of the Naval Safety Center Presents:

FLASH

Factual Lines About Submarine Hazards

Jan 2004 - Mar 2004

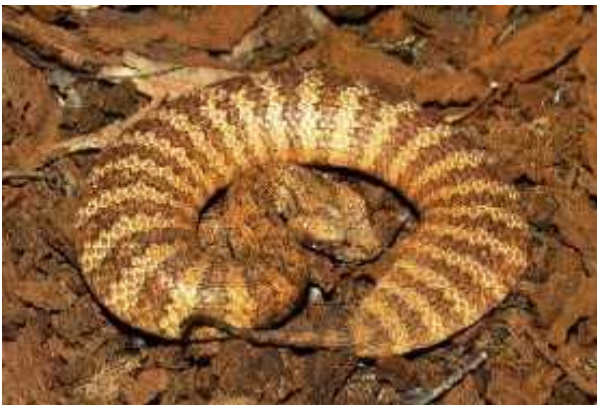
work does not. A prime example of this problem is the increase in the number of improperly dead-ended cables noted during our safety surveys.

Much of the time these improperly dead-ended cables are "leftovers" from contractor and outside activity work performed for ship's force during inport availabilities. They are tucked away in the overhead or shoved behind the serving line in the galley. They may be de-energized and have tape over the business end or they may still have power applied and are awaiting that unsuspecting Culinary

Specialist to strike down like a death adder (see photo).

installed, but cannot remove the excess cabling in time for the ship to meet its operational commitments. The solution is to have the cabling dead-ended properly IAW NSTM 300-4.6.9 and DOD-ST-2003-1. To do this, the power supply is either tagged out or removed. Both ends of the cabling is disconnected, insulated, and sealed. A work candidate is generated to have the dead-ended cabling removed at the next FMA availability per the JFMM (4790.3 Rev A VI-28.5.d). Finally, the ends are tagged with a manila-type document tag indicating that the cable power supply has been secured, the cable is de-energized, and the JSN is active for its removal.

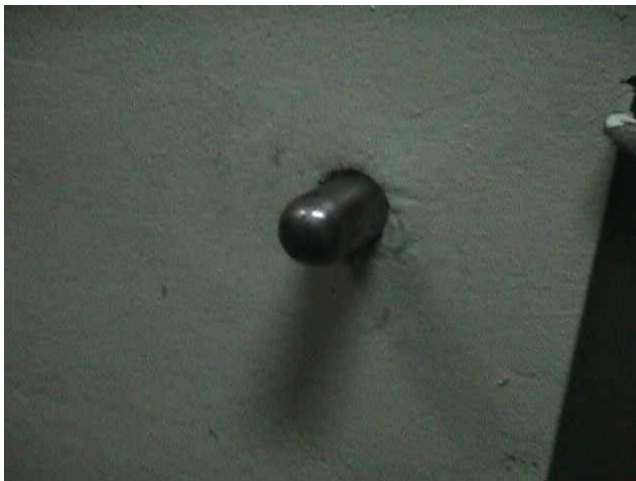
IAW NAVSEA OP 4 Rev. 7 par. 5-6, for pyrotechnic lockers, thermometers may have a range of 20 to 240 degrees. Once again, the thermometer must be a 3-inch, back-connected dial, but with a 2-inch stem.

View of correct thermometer well

Available in the supply system is a bi-metallic thermometer with a 2-inch stem. To order this thermometer use the following: NSN 6685-01-216-7147

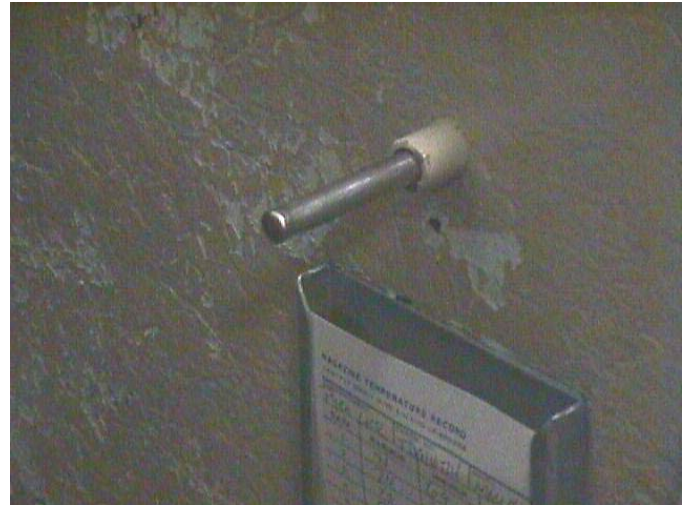
View of incorrect/altered thermometer well

Do not perform an unauthorized alteration and cut the thermometer well to make room for the stem!

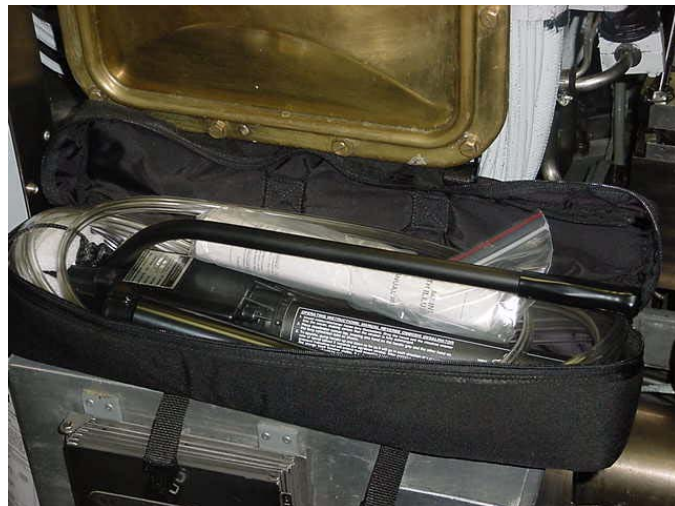
It comes with two cards. First is the Q-1R. The Q-1R provides a visual inspection of each unit. This card ensures the units are complete and in satisfactory condition.

Next is the 48M-1. The 48M-1 details a test maintenance procedure. I strongly recommend you complete the 48M-1 on all of your desalinators upon receipt of PMS FR 1-04. The reason, all the SEIE suit boats I have surveyed have desalinators that were manufactured at least six years ago. Completing the PMS now, versus 48 months from now, will ensure the equipment functions properly.

Desalinator Kit
