RI 9639

REPORT OF INVESTIGATIONS/1997

Detection of Downed Trolley Lines Using Arc Signature Analysis

Jeffrey Shawn Peterson and Gregory P. Cole

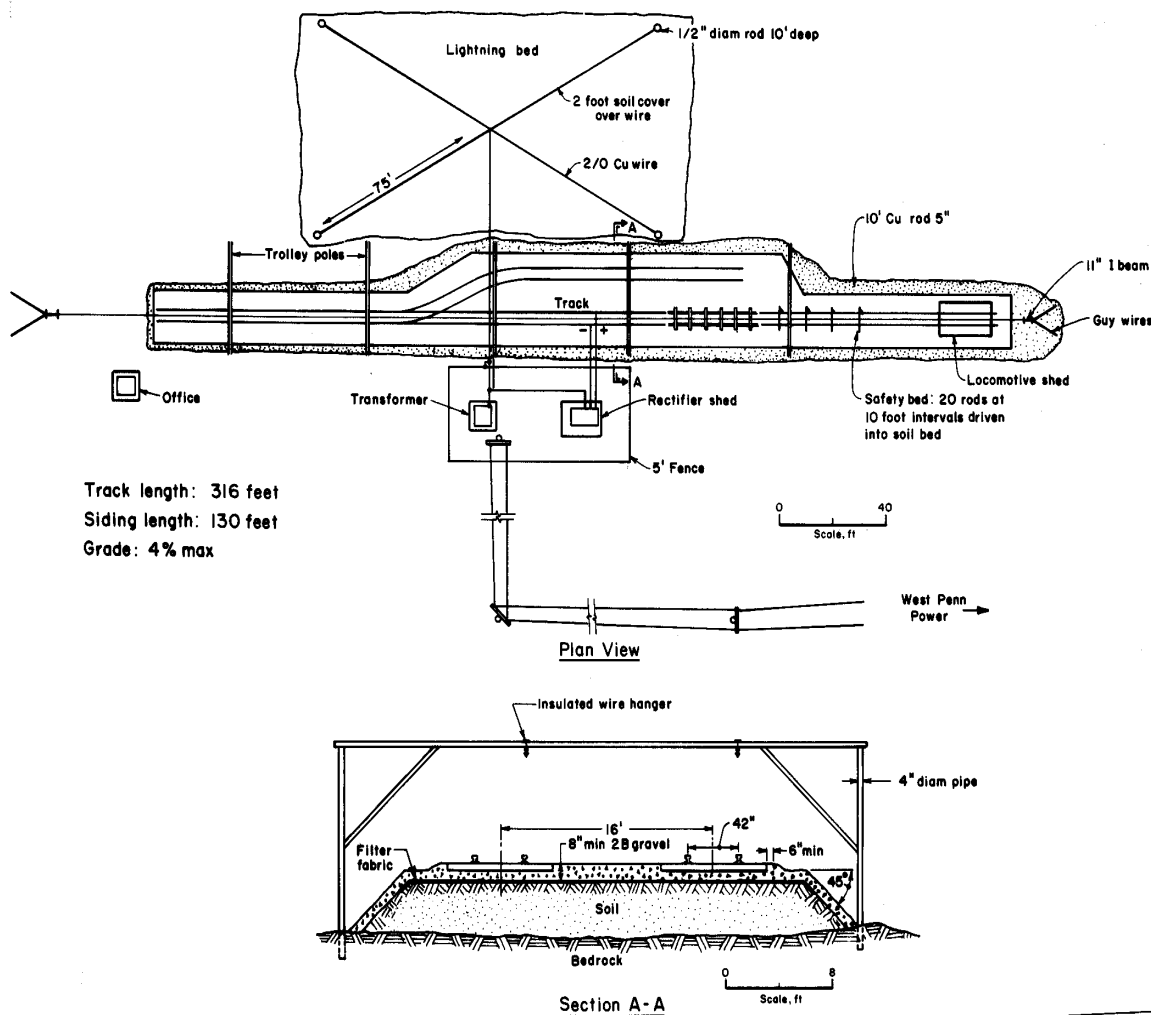
Figure 1.—Lake Lynn Laboratory trolley system.

Our Lake Lynn Laboratory facility near Fairchance, Fayette County, PA, was chosen as the initial test location (figure 1). The facility had an on-site trolley system that was unused for several years, but was suitable for use after refurbishing and making minor safety modifications. A 12.47/2.3-kV, three-phase transformer supplied electrical power for the Lake Lynn

trolley. This fed an oil break switch and a 2,300/222-V delta-delta transformer in a rectifier building. A 300-kW, 300-V dc rectifier employed a wye-wye bridge arrangement. This was connected to 4/0 American wire gauge (AWG), figure-eight trolley wire and 1.1-m (42-in) gauge track at approximately the midpoint of a 96.3-m (316-ft) straightaway with a 4% grade. A 10-ton locomotive and several 10-ton rotary dump cars stored on a 39.6-m (130-ft) spur were available for use.

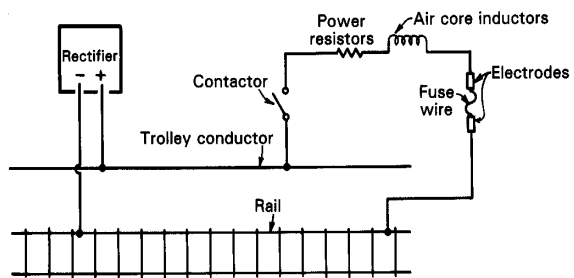
Figure 2.—Trolley arcing fault test circuit used at Lake Lynn Laboratory.

Techniques were developed at Lake Lynn to safely induce arcing faults on trolley systems. Multiple 0.3-ohm power resistors and air core inductors limited the fault current and simulated increased haulage distance, respectively (figure 2). Copper, steel, and aluminum rods served as electrodes through which the arcing current flowed. A wooden and steel bracket

either manually or via a fiber optically isolated control switch. This fault circuit was simply clamped to the trolley wire and rail system. Except for the air core inductors, this equipment was later used during recording and monitoring sessions at cooperating mines. Shunts installed on the rectifier negative conductor provided the current signal, and the voltage was measured with a voltage divider installed directly across the rectifier output.

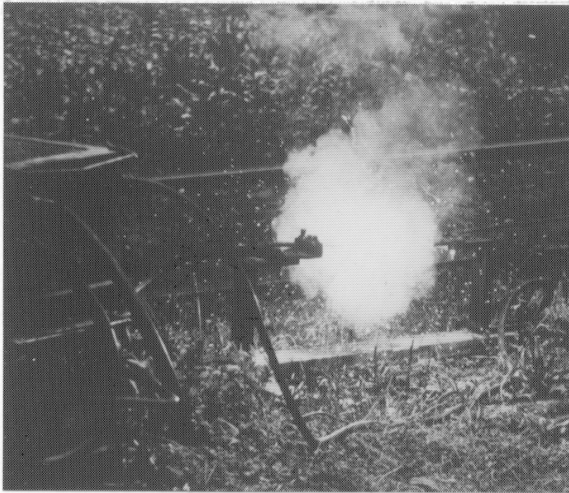
Figure 3.—Metallic electrode configuration during an arcing fault.

held the electrodes in place, and 18 AWG copper wire served to complete the initial current path (figure 3). After the fuse wire melted away, arcing continued between the metallic electrodes. Finally, a contactor switched the fault into the trolley circuit

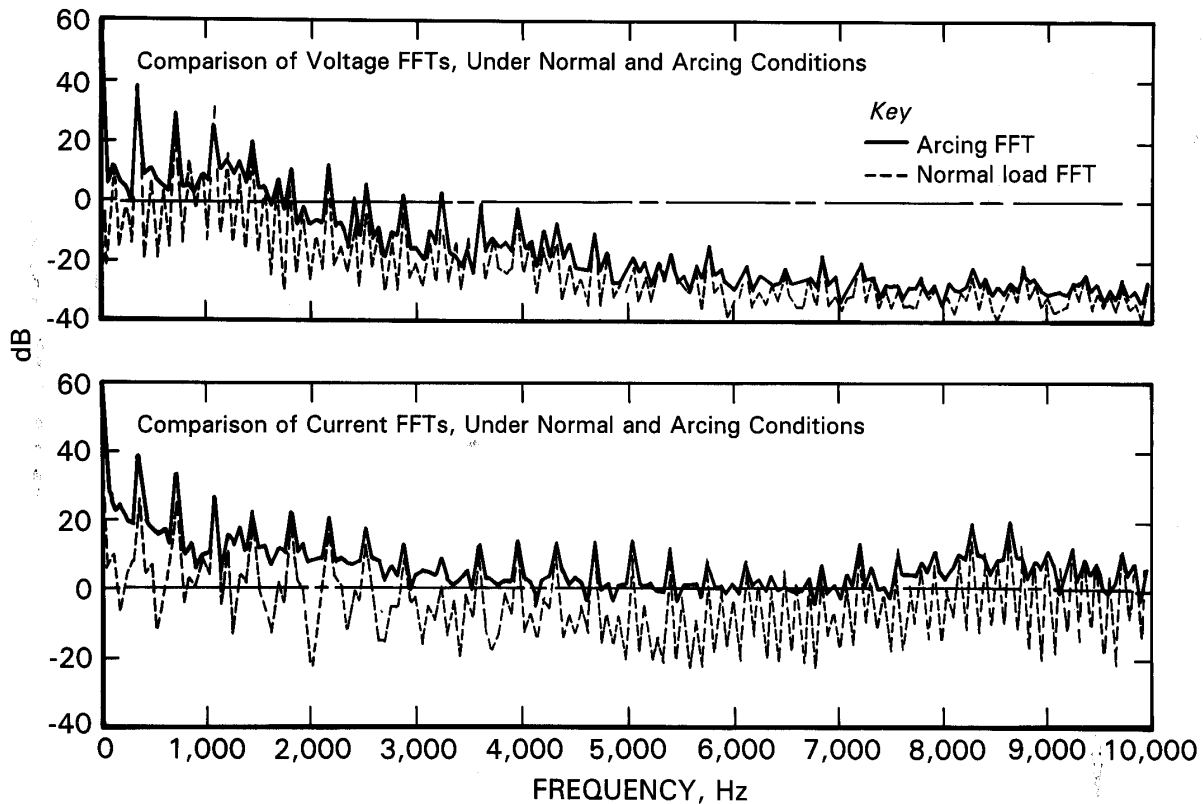
Figure 4.—Comparisons of the variations between the current and voltage fast Fourier transform spectra under normal and arcing fault conditions.

case of a fault. Secondly, the current FFT's show a wider variation in components when comparing normal and faulted spectra (figure 4) than does the voltage. Figure 4 shows that there are significant differences in the two current spectra up to 10 kHz, whereas the two voltage spectra are comparatively the same above 5 kHz.

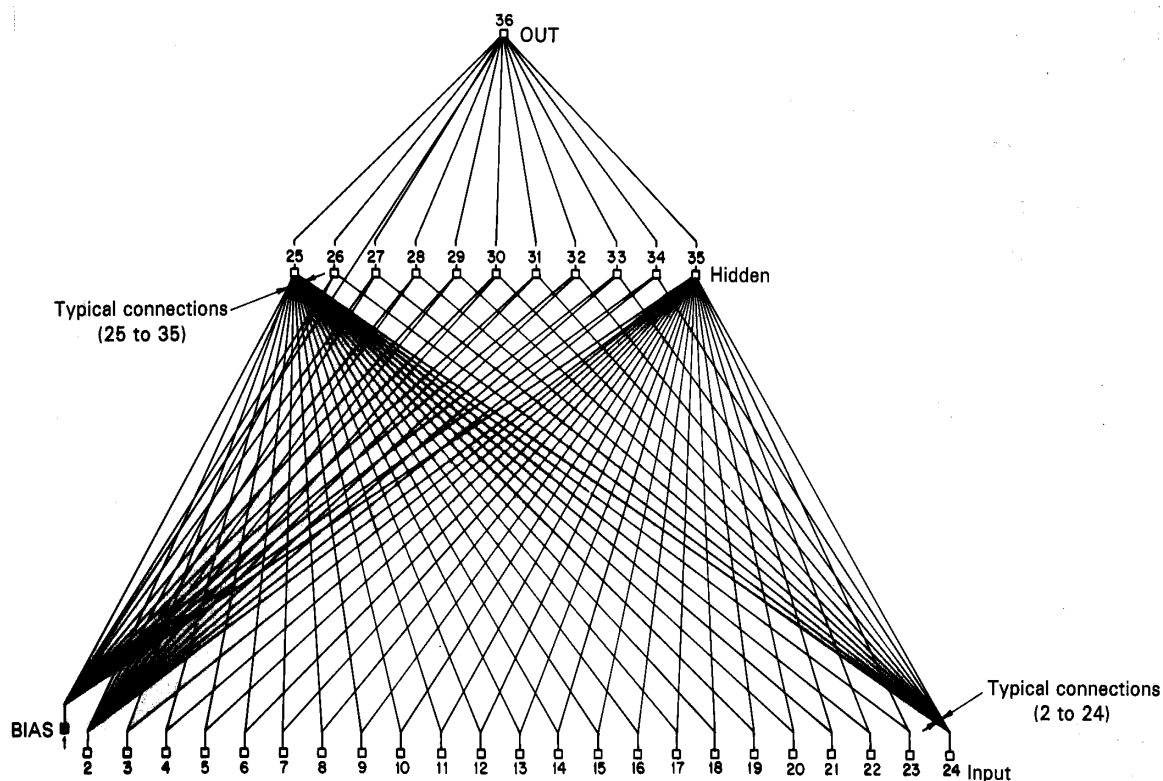
Figure 5.—Topography of the neural network showing the layers and interconnections.

Figure 5 shows the topography of the neural network deployed for field testing. It consists of 23 input nodes, 11

hidden nodes, and 1 output node. Each node, or processing element, represents a single neuron that, when grouped together, form a network. The 23 inputs to the network are the FFT spectrum components of the current. They cover the 60-Hz harmonics starting at 1,440 Hz and ending at 2,760 Hz. Connections from the input layer to the hidden layer and from the hidden layer to the output node form the "memory" of the

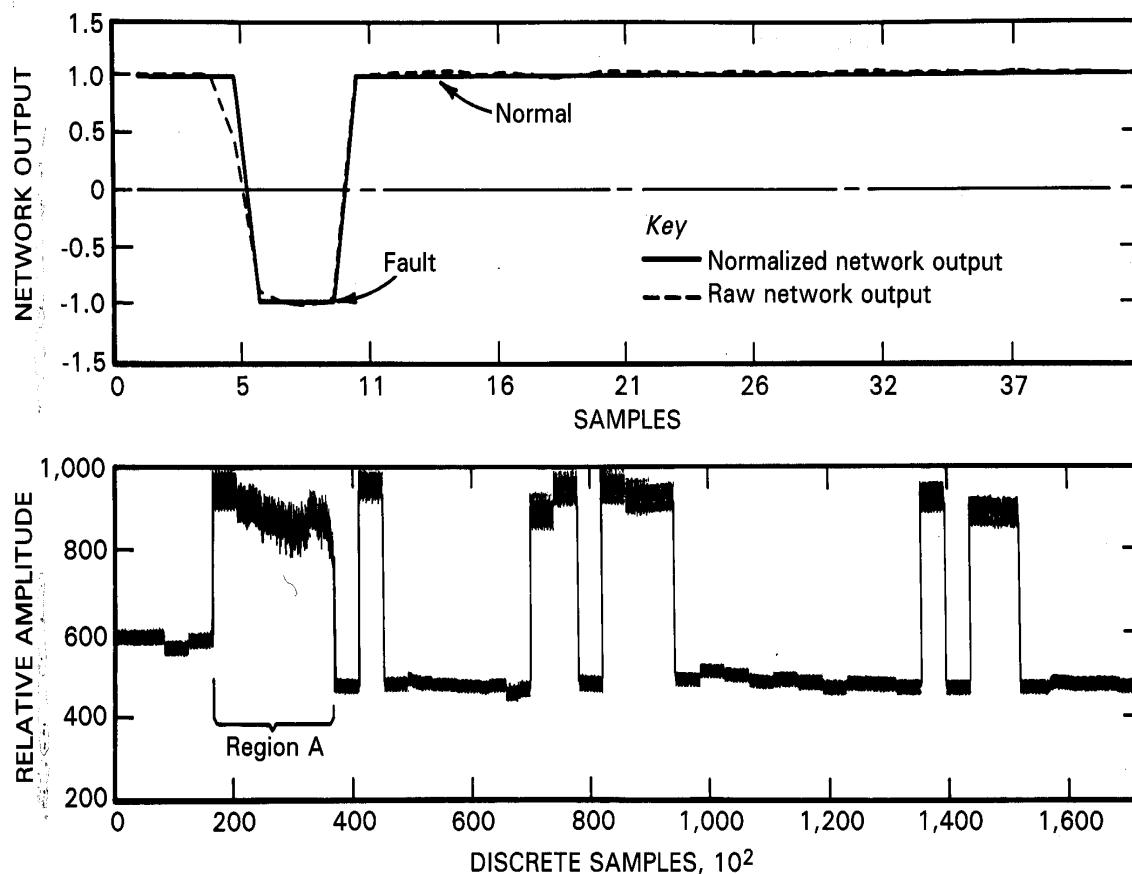
Figure 6.—Comparison of the raw and normalized neural network output with the corresponding rectifier current signal. Region A is where the fault occurs in this test amid normal loading from the locomotive.

-0.5 are considered a fault, whereas all values above are considered normal. Figure 6 illustrates the normalizing scheme, with the results displayed above the corresponding rectifier current log. Region A is where the fault occurs in this test amid normal loading from the locomotive. Applying the threshold increases the accuracy of the network through accepting only classifications with a high degree of confidence, thus decreasing the chances of a false alarm. After setting the threshold, the second step is to round the output to either a $+1$ or -1 value and display it on the DDA screen.
