TIOSH ALERT

Preventing Injuries and Deaths from Falls during Construction and Maintenance of Telecommunication Towers

DHHS (NIOSH) Publication Number 2001–156

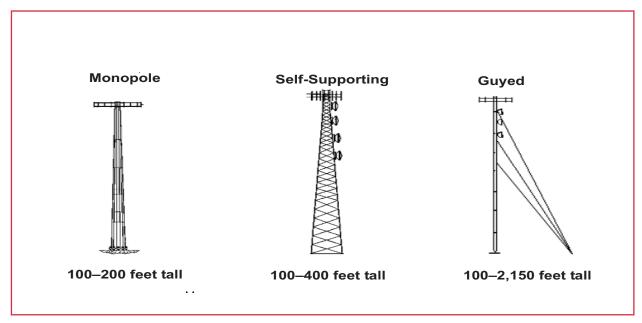
- monopoles that consist of tapered steel tubes that fit over each other to form a stable pole,
- guyed towers that are stabilized by tethered wires, and
- self-supporting towers that are freestanding lattice structures (Figure 1).

Figure 1. Tower types.

Telecommunication towers may be of several types and range in height from 100 to 2,150 feet or more [OSHA 1998]. Three general forms of telecommunication towers are

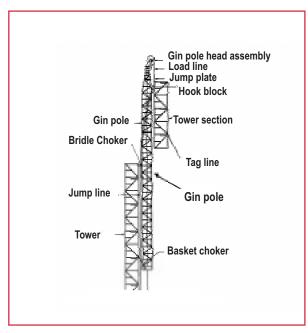
Telecommunication towers are generally manufactured as sections and constructed onsite by hoisting each section into place and bolting sections together. Some models of shorter towers are self-erecting. For most towers that are constructed onsite. cranes and gin poles attached to the tower being erected are generally used to hoist each section into place. A gin pole is a device unique to the telecommunication tower industry. The gin pole is used to raise successive sections of steel, equipment, or workers into position. This temporary lifting device uses cables and pulleys to allow enough head room to accommodate the length of the next tower section or equipment being installed (Figure 2).

Figure 2. Gin pole attached to communication tower.
