Aviation Accident Review

Department of the Interior Aviation Accident Review

Office of Aircraft Services

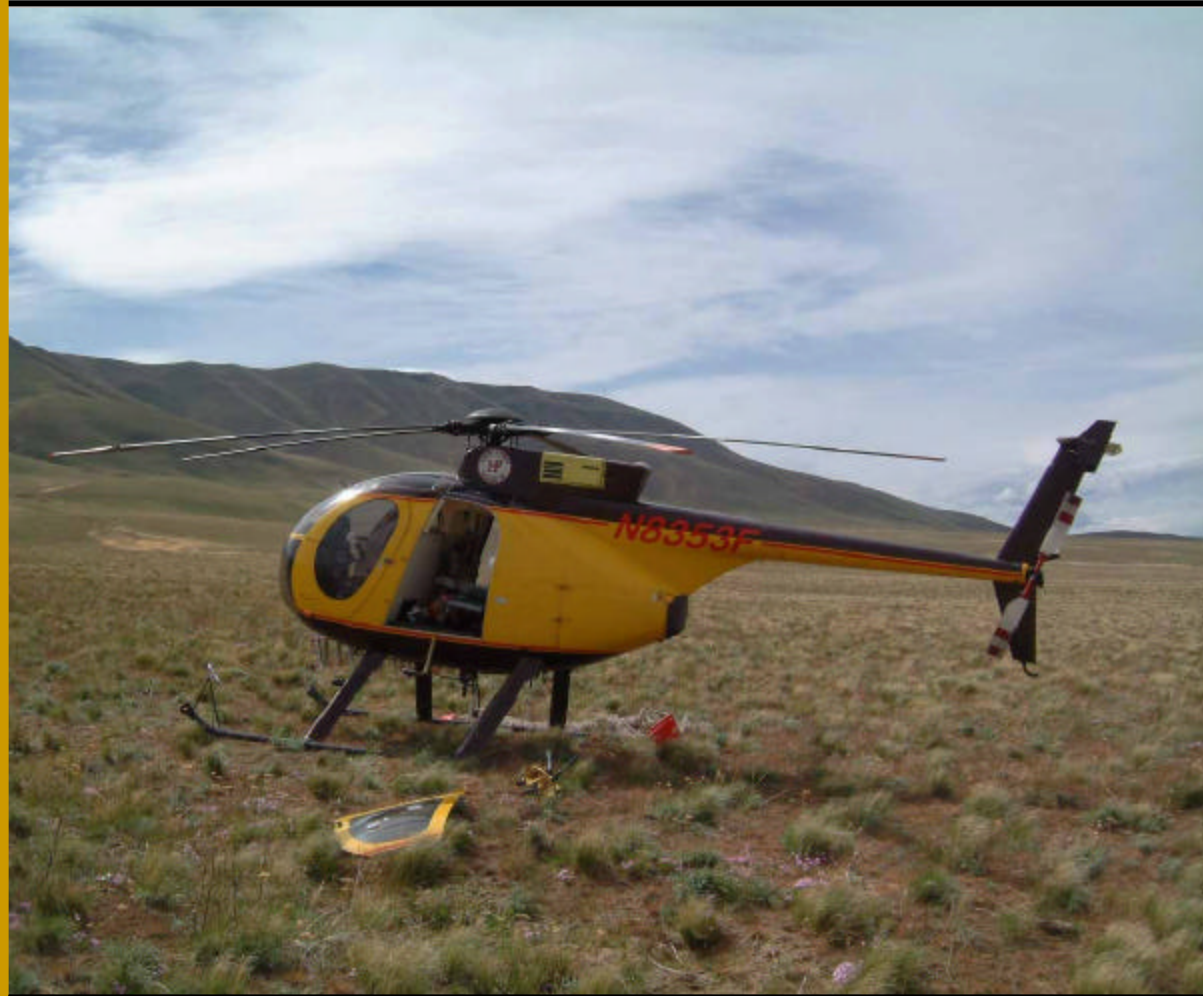
Top of Rotor Blade

While using a net gun on an elk capture mission one of the net's weights struck the red main rotor blade causing substantial damage.

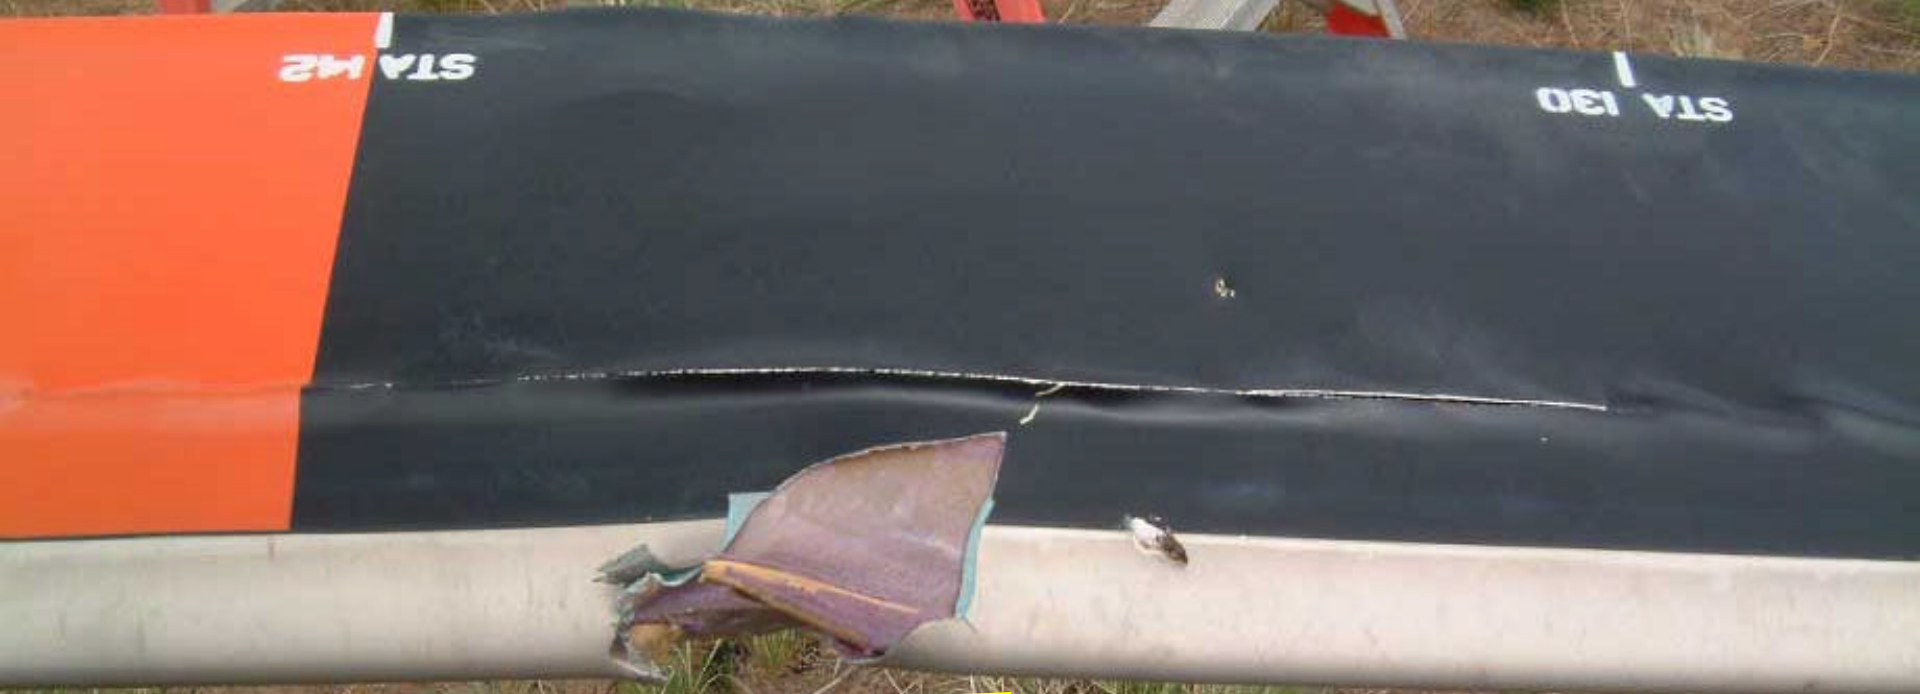
Rotor Blade

**Leading edge
and spar**

Leading edge damage

Spanwise
damage

Chordwise
damage

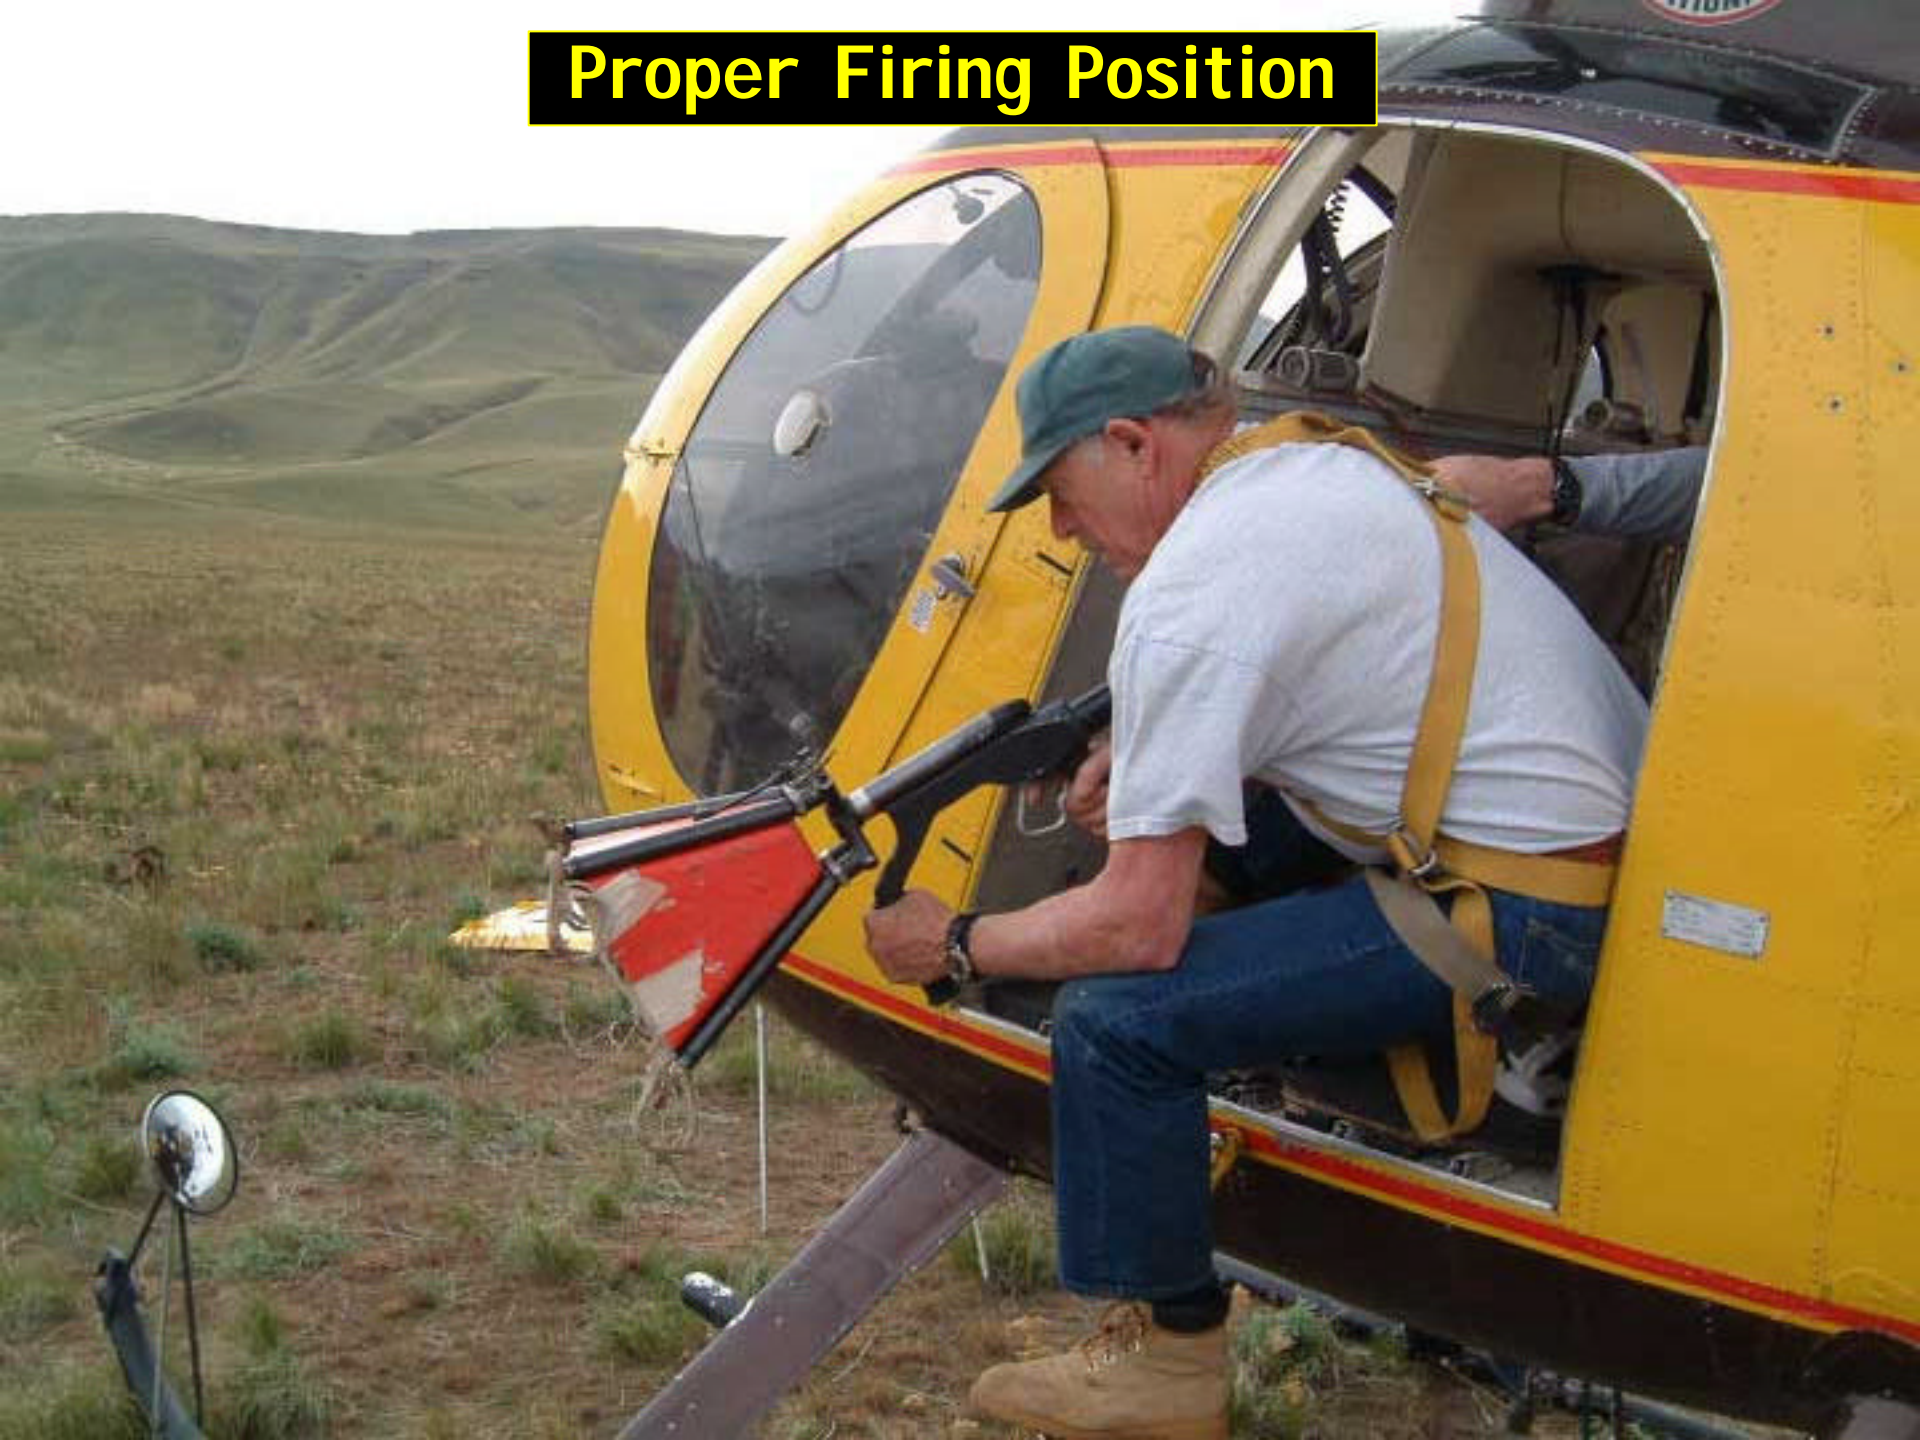
Proper Firing Position

Note two points of failure

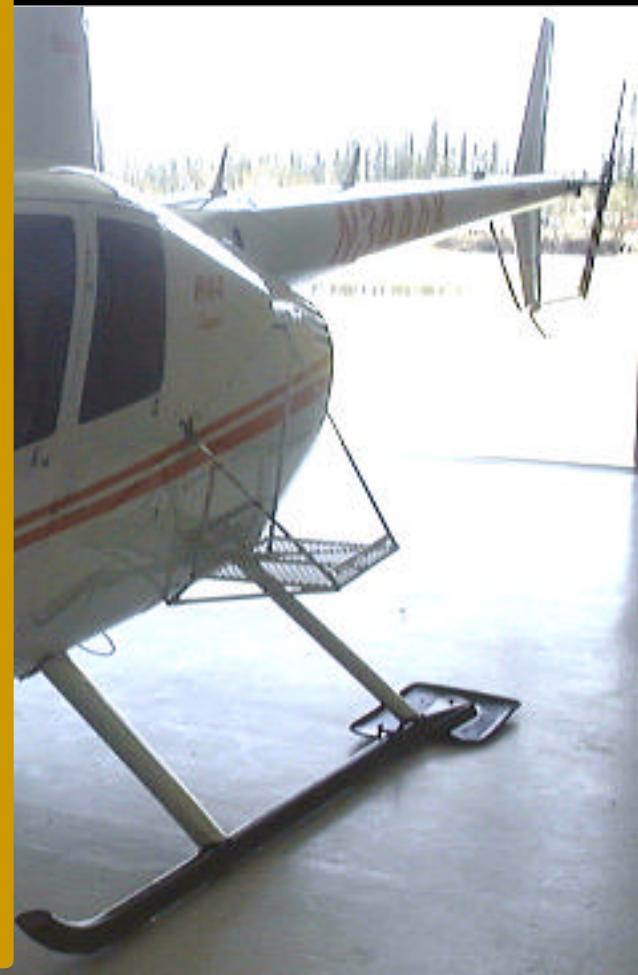
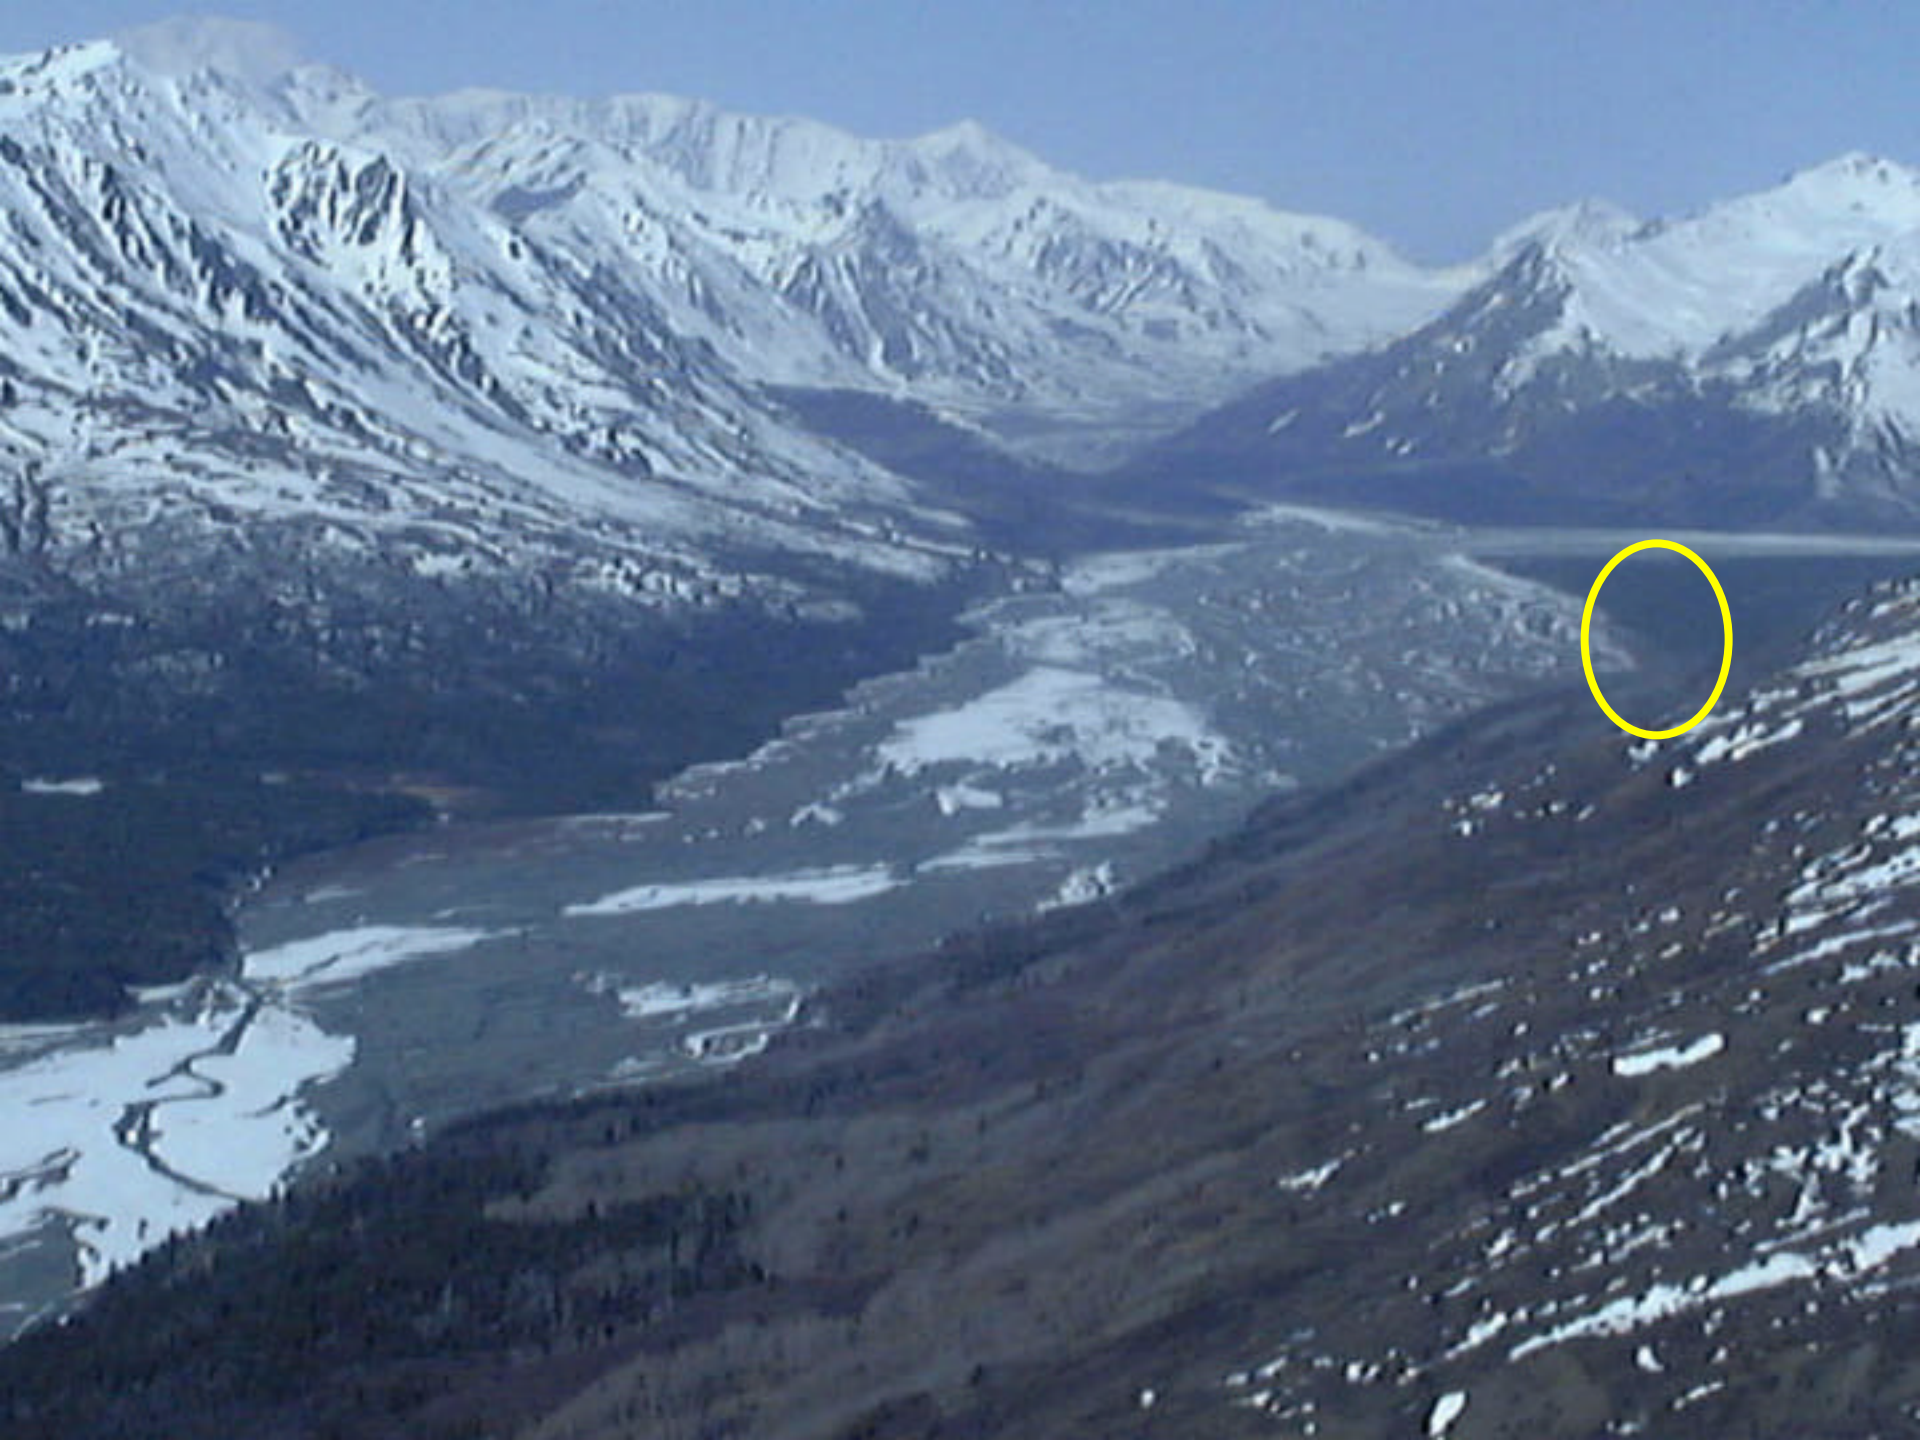
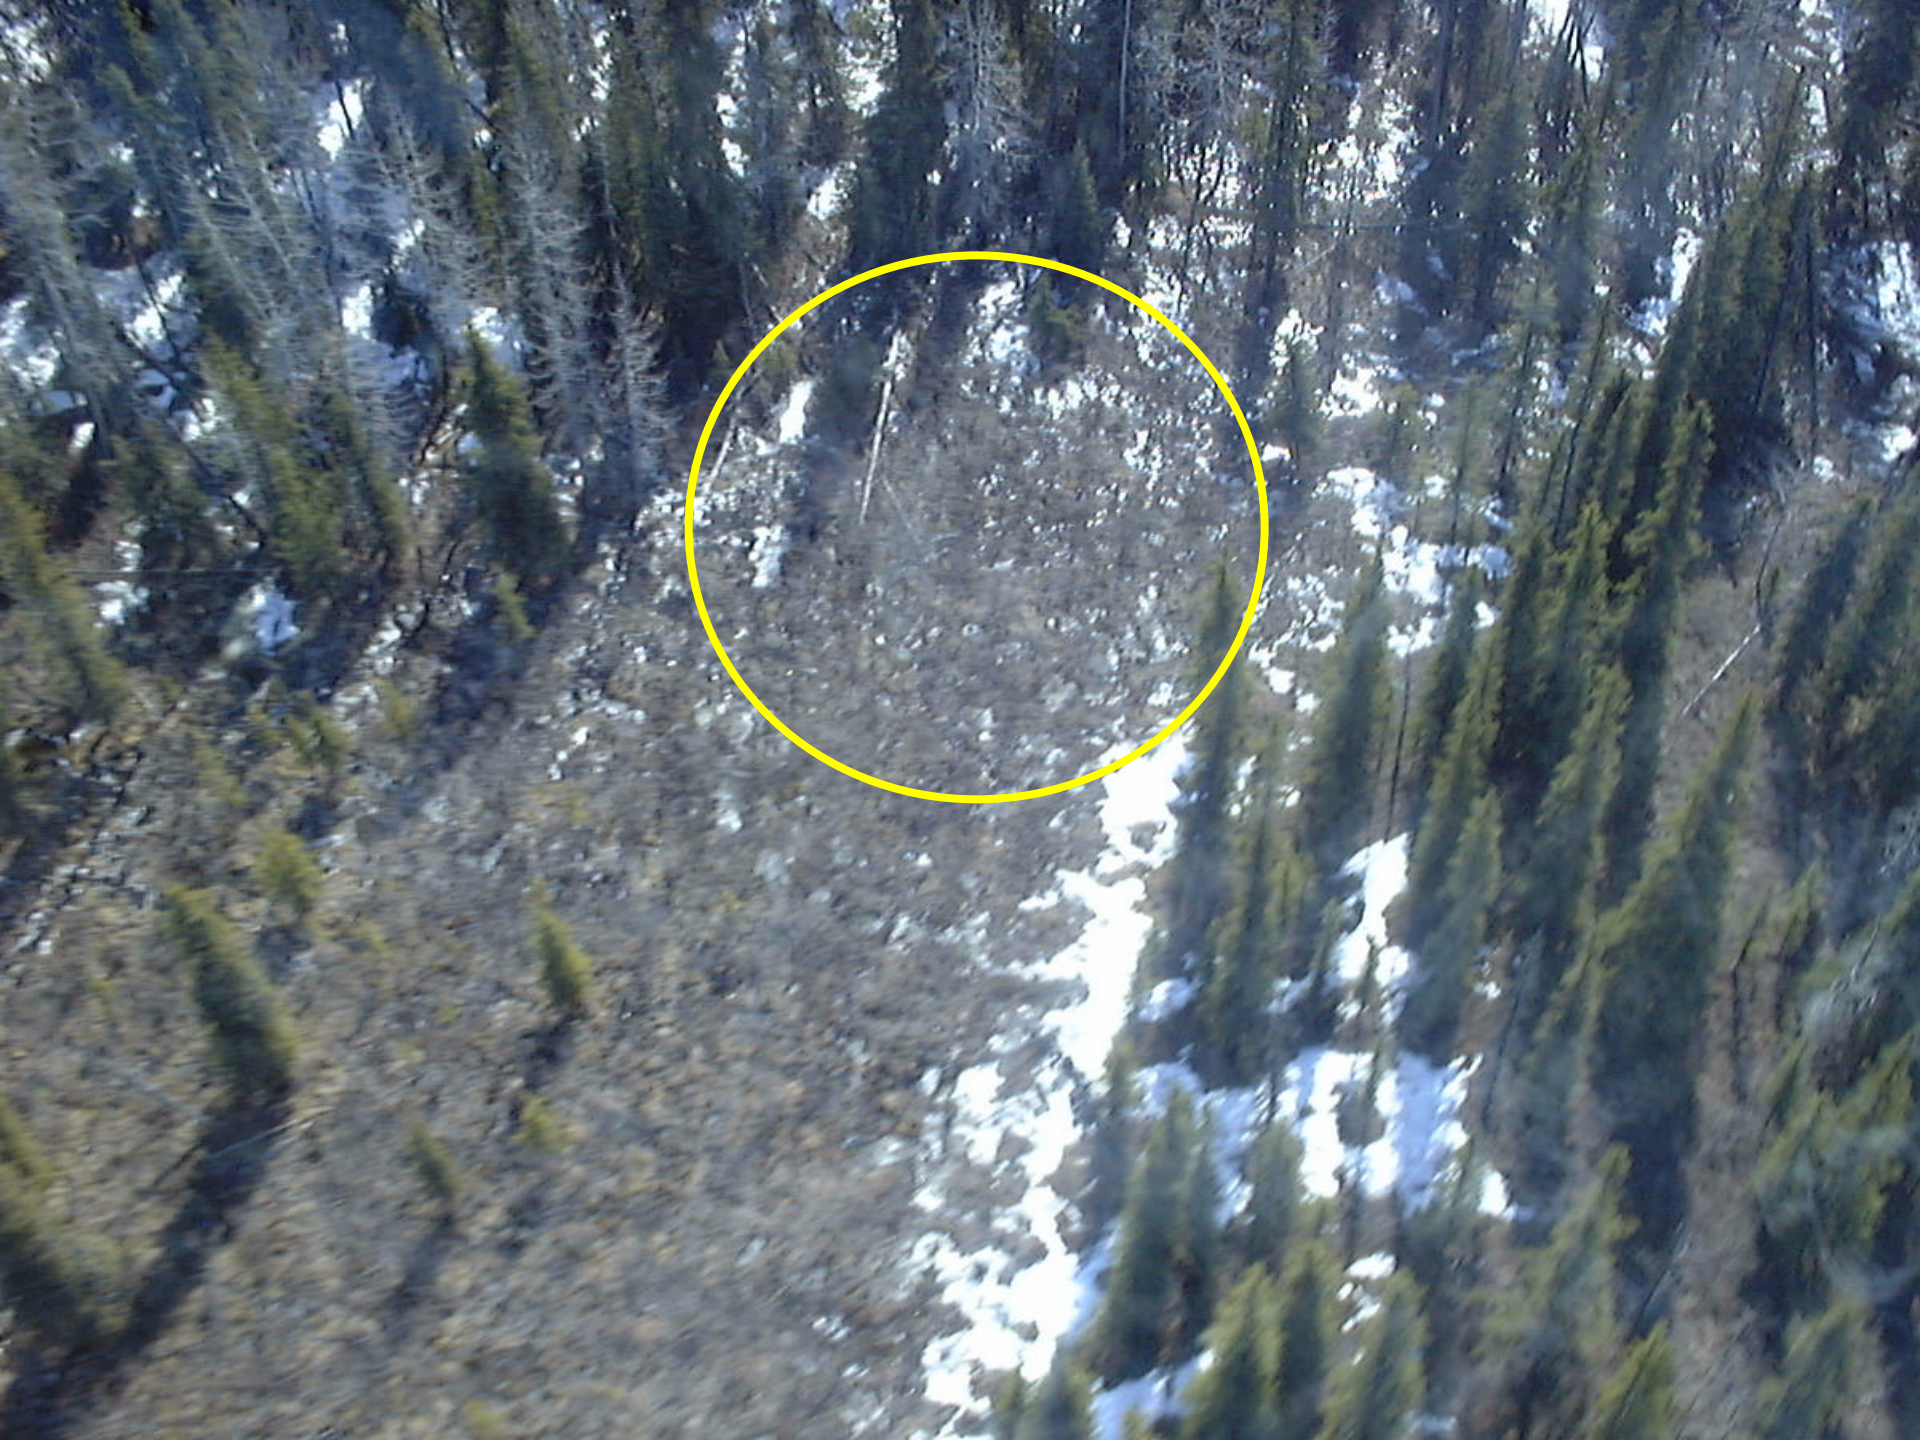
After landing the pilot found damage to both main rotor blades.

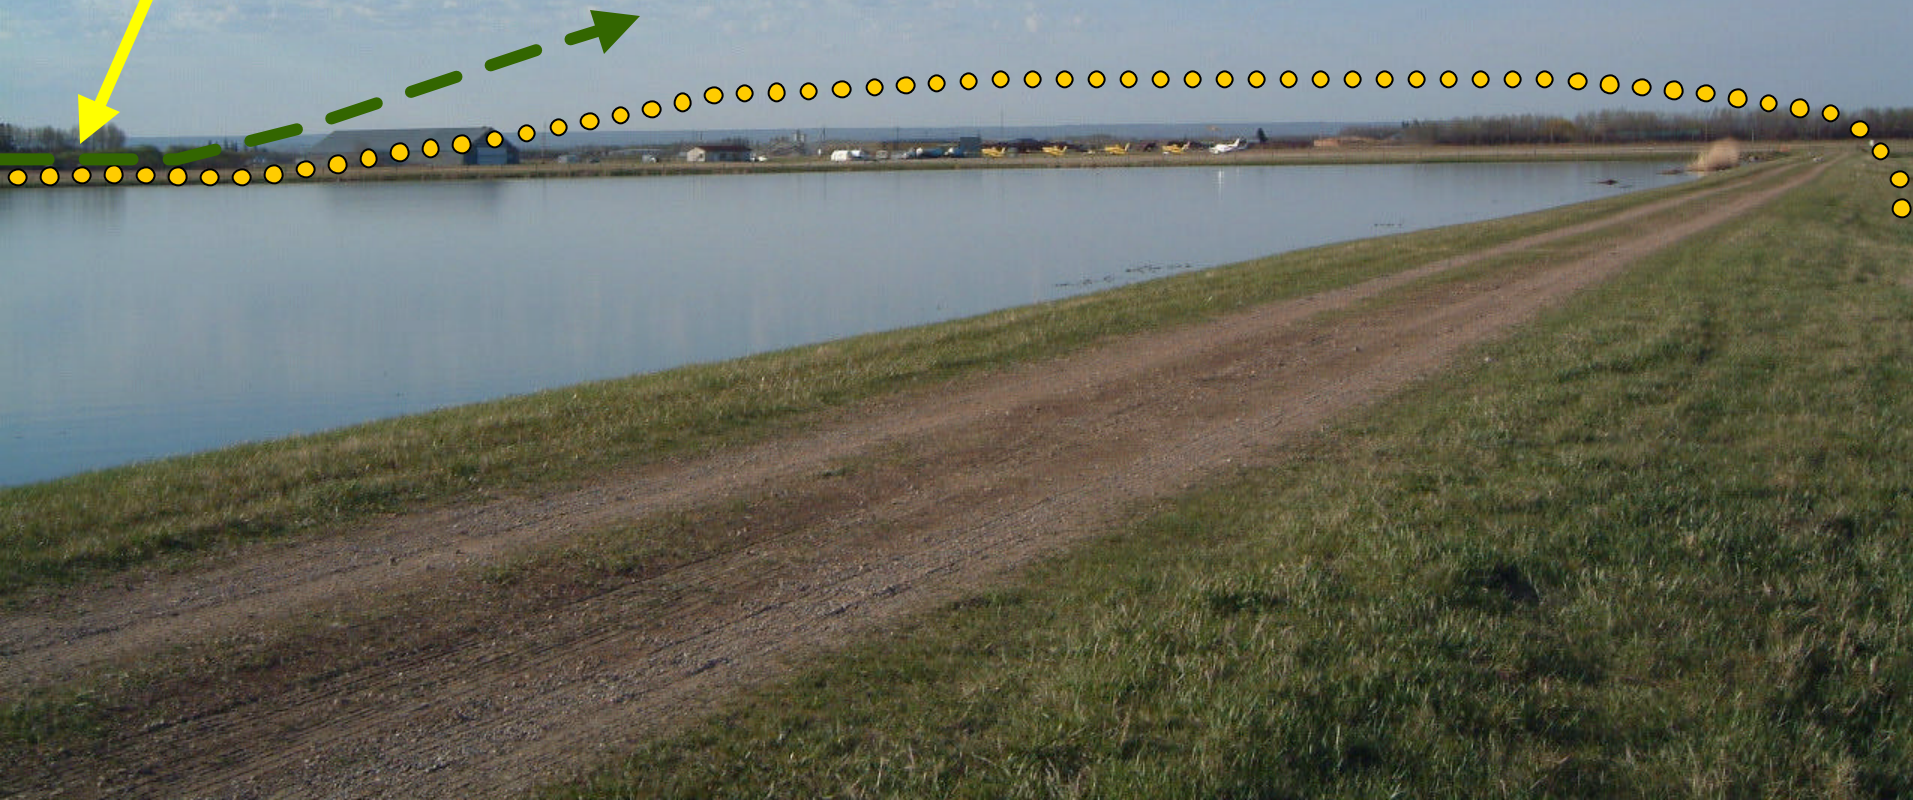
Float impact

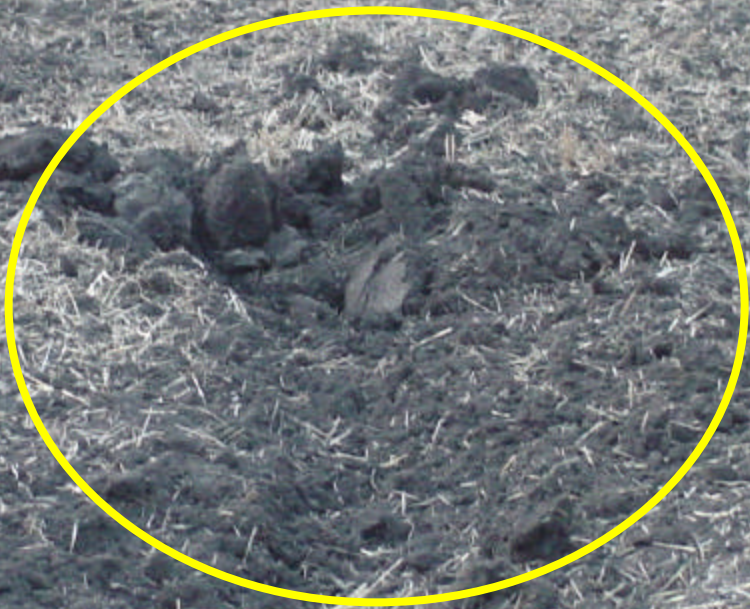
Prop impact

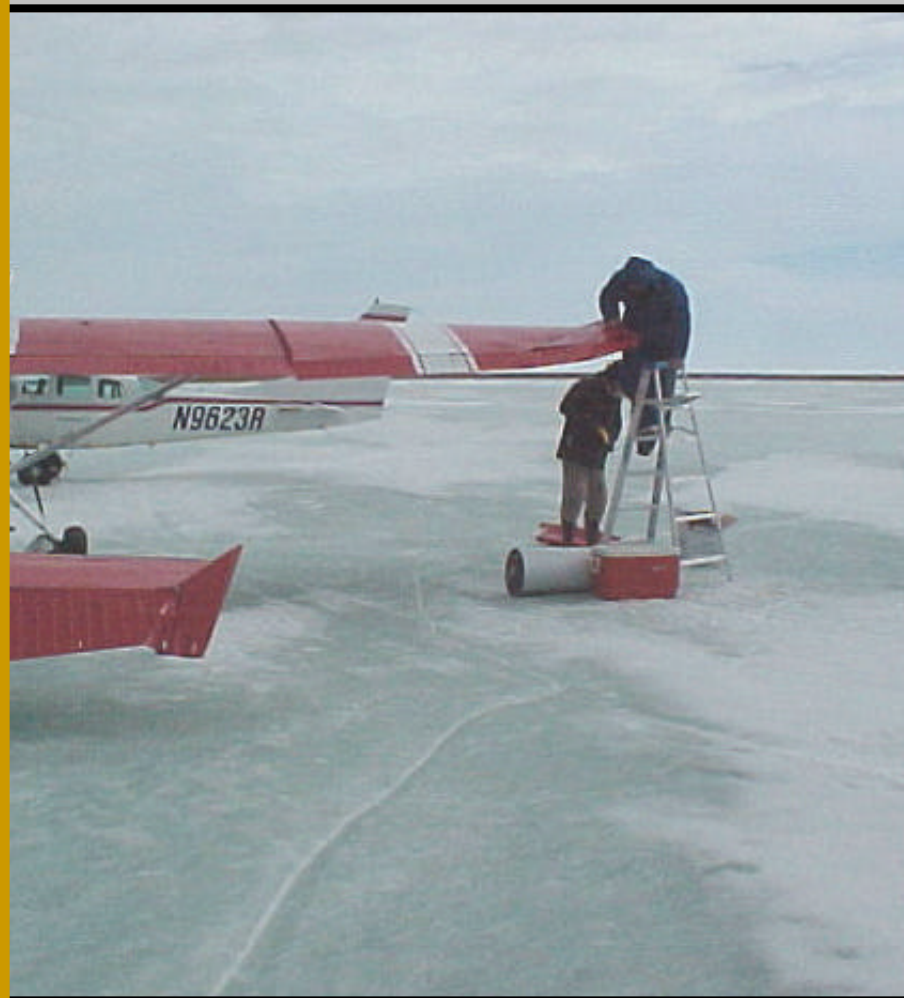
**Field repair
to leading edge
of right wing**

**Damage to leading edge
of right wing
(duct tape removed)**

Aircraft damage was repaired and the aircraft was moved to Fairbanks in violation of 49 CFR 830.10
