SAGAMORE HILL HOME OF THEODORE ROOSEVELT

Sagamore Hill National Historic Site
Oyster Bay, New York

Historic Structure Report

Building Conservation Branch, Cultural Resources Center
North Atlantic Region, National Park Service
U.S. Department of the Interior
Boston, Massachusetts

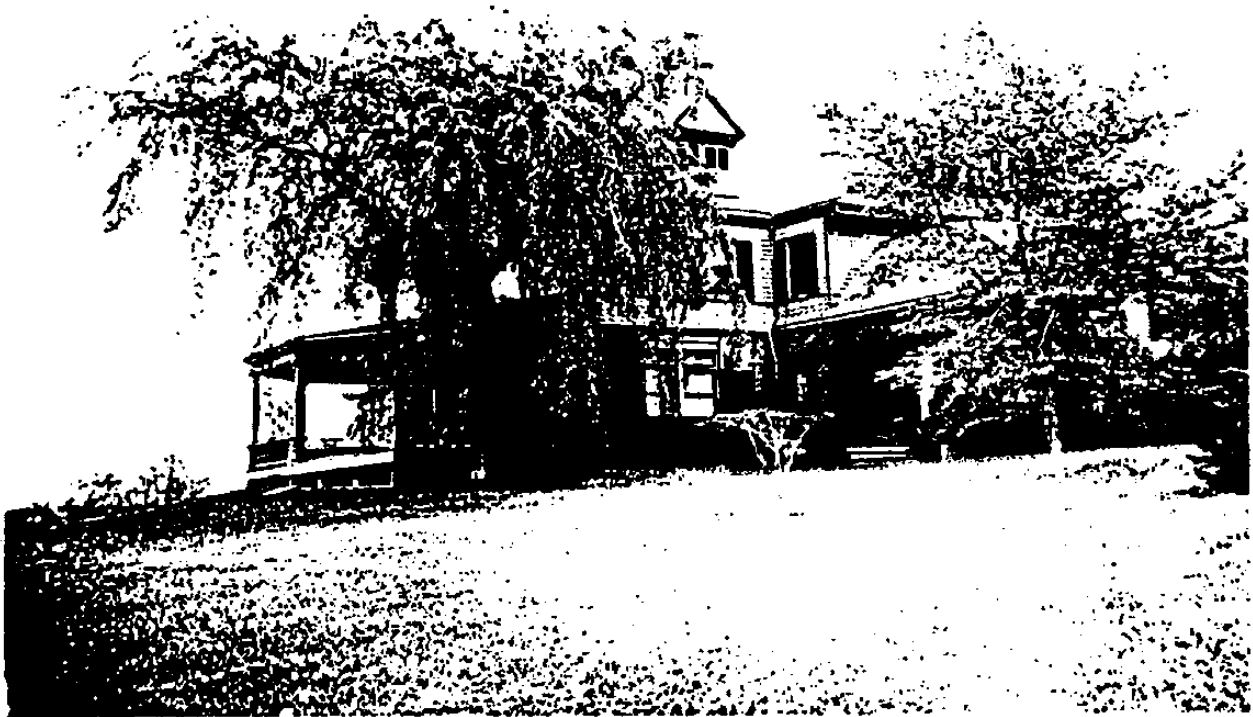
1. Sagamore Hill - c.1905

House had a polychromatic color scheme.

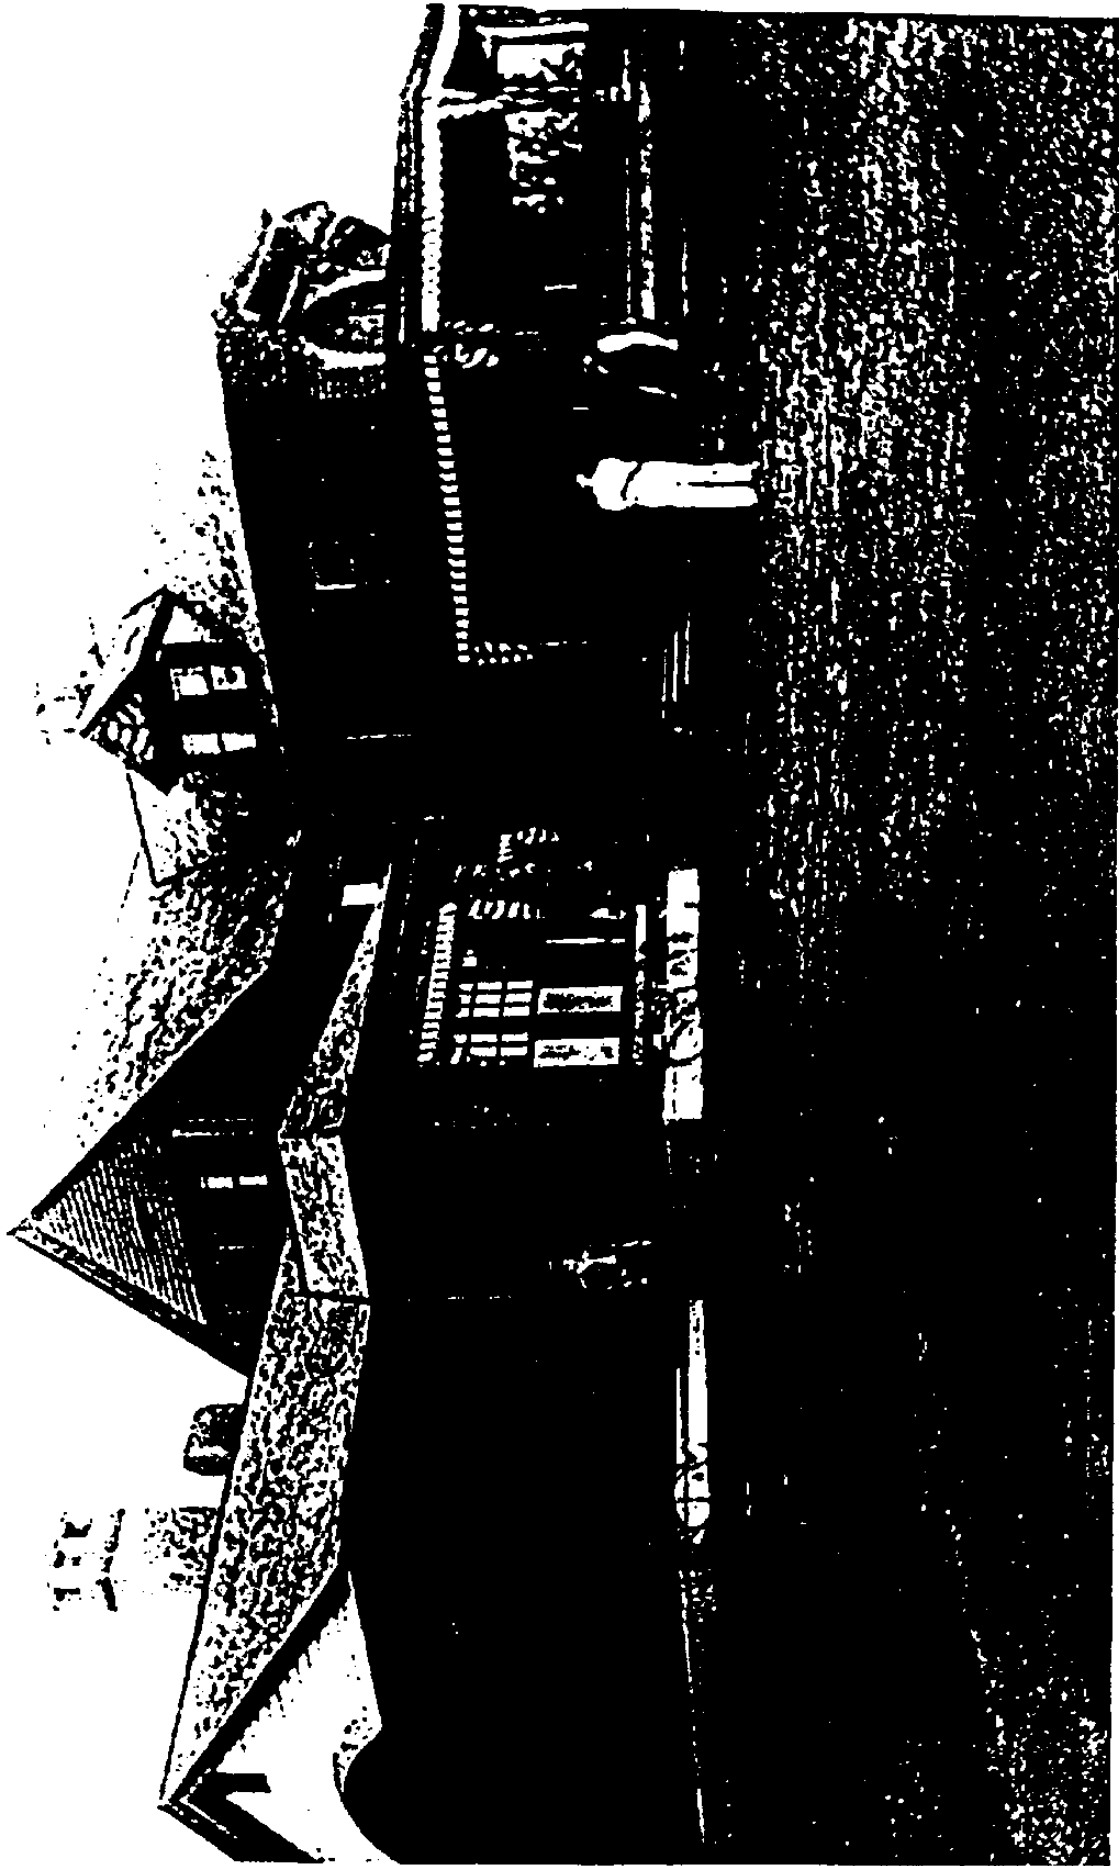
3. Sagamore Hill - c. 1905

Trophy Room has been built. The shingles at the north end of the Trophy Room and the brick walls appear to be unpainted. The wood trim is painted a dark color. The c.1884 portion

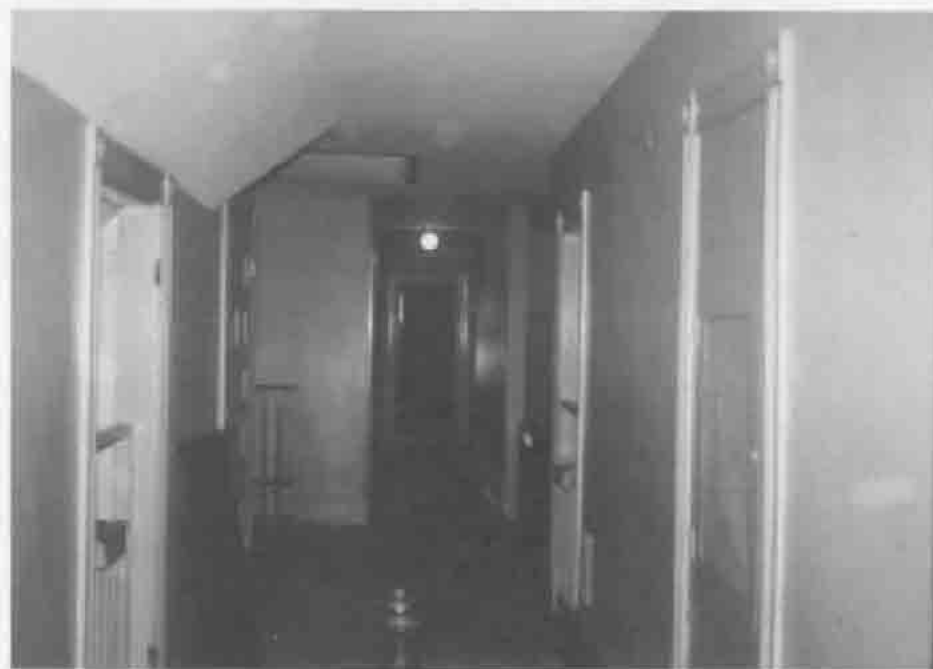
Third Floor Hall: Before Restoration

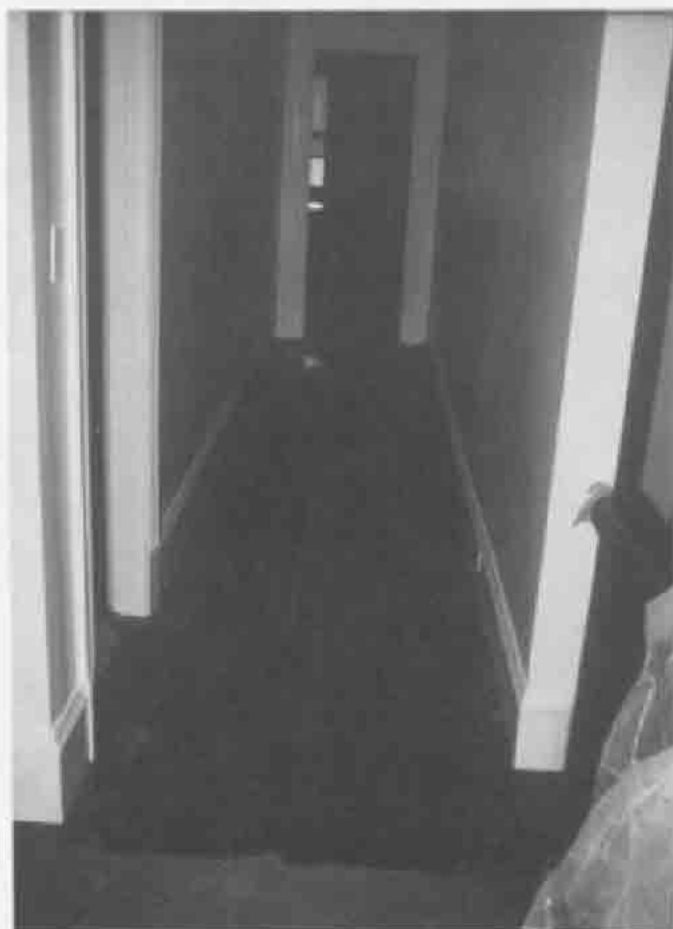
Third Floor Hall: After Repainting

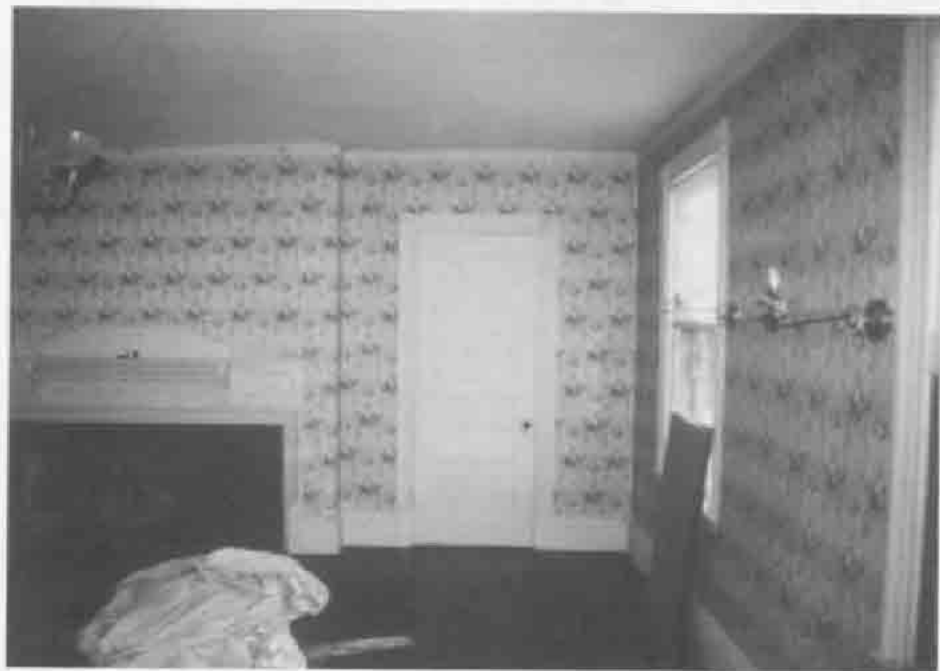
South Bedroom: Before Restoration

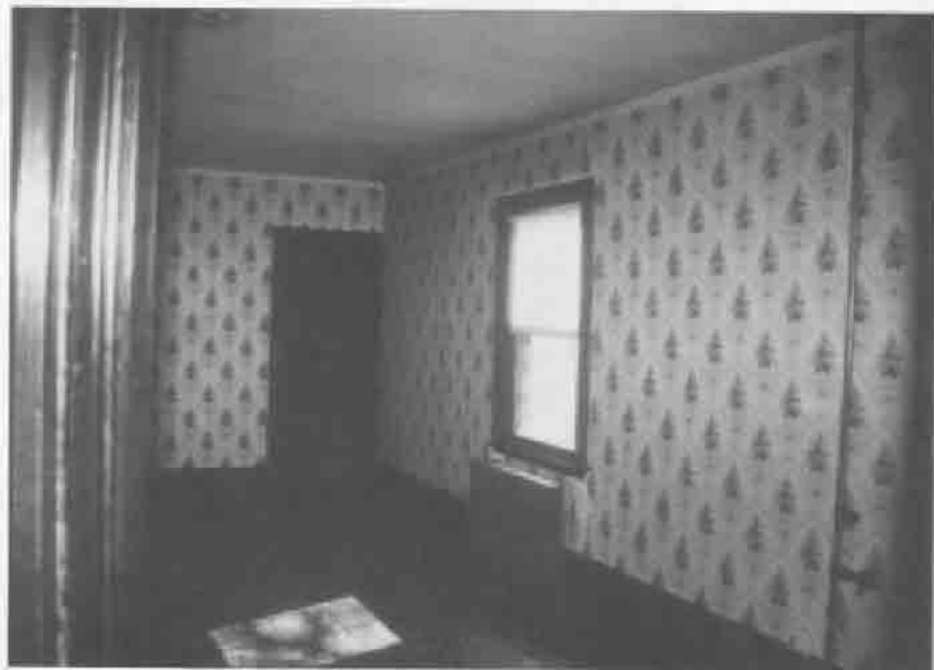
Alice's Room: Before Restoration

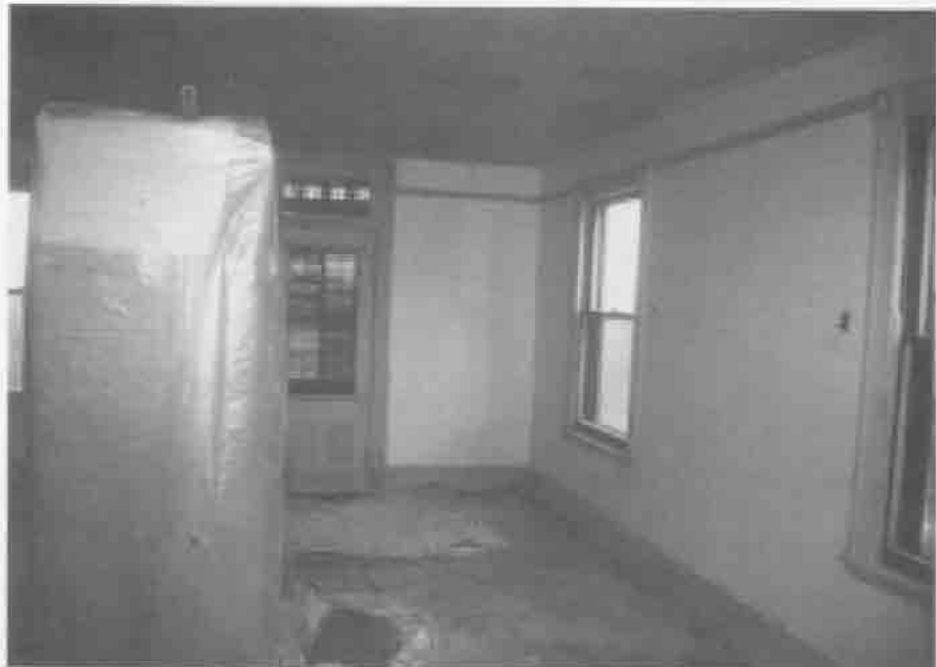
Mother's Room: During Restoration (wallpaper removed, picture molding lowered).

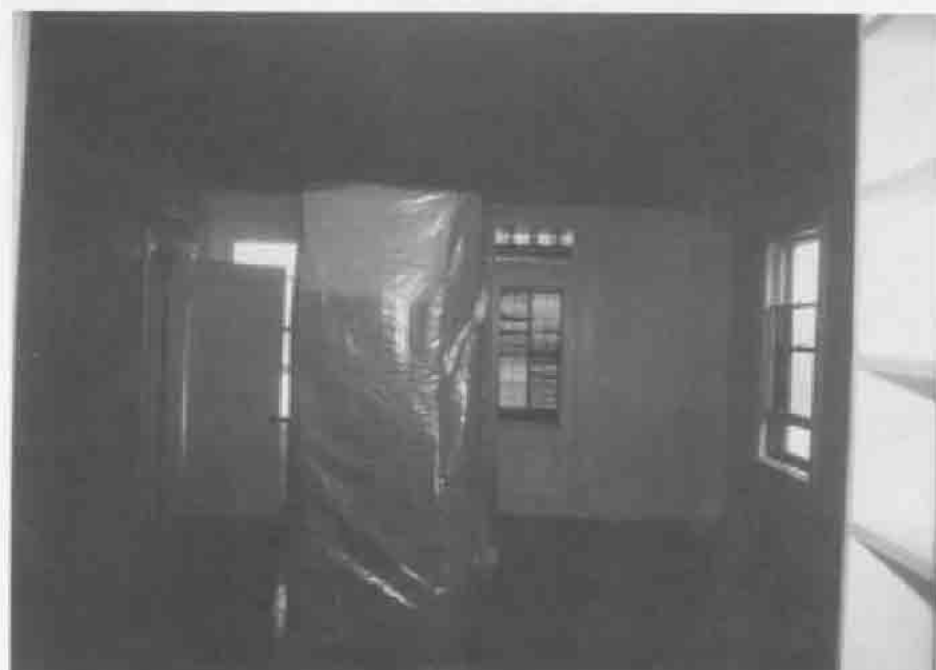
Mother's Room: After Restoration

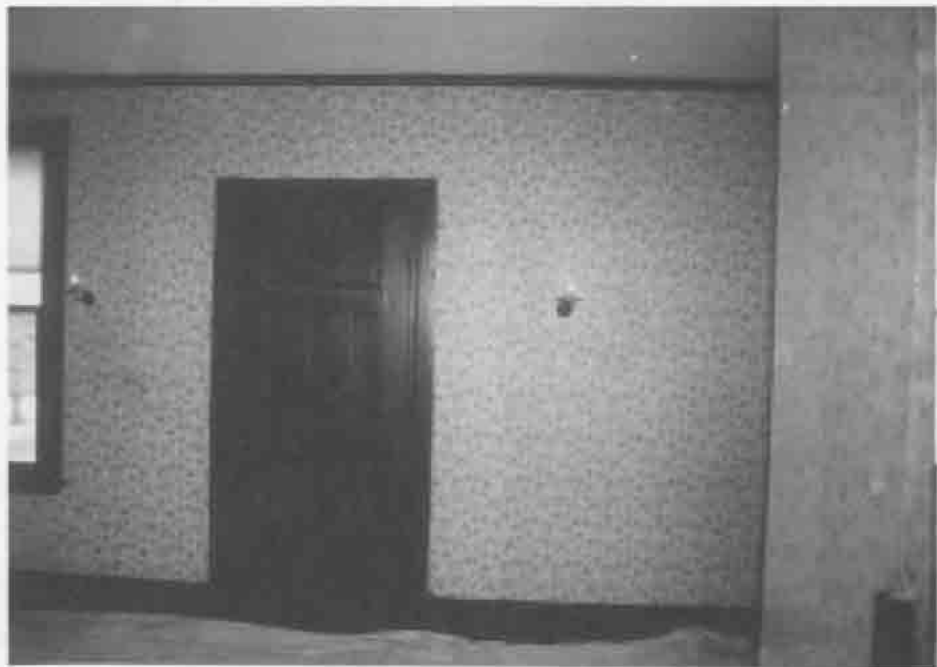
Nursery: Before Restoration
